Nevadaville Historic Resources Survey: Phase I
SURVEY REPORT
June 2015

Nevadaville Historic Resources Survey: Phase I 2014-2015

Survey Report June 2015

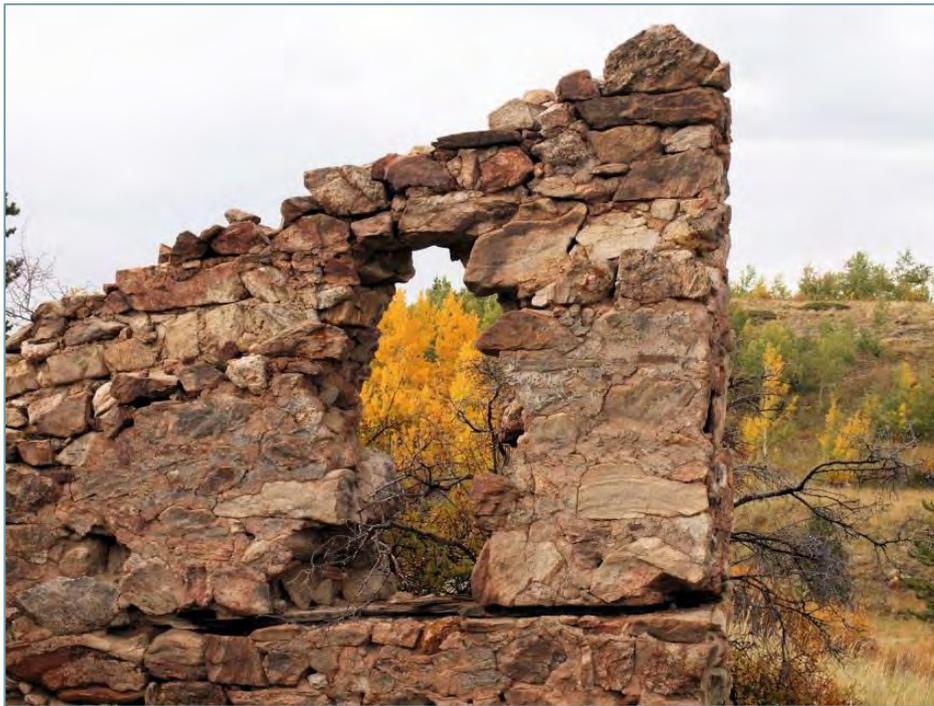
Figure 1-1. Ruins of a house on Clarence Street, showing Cornish rock masonry.

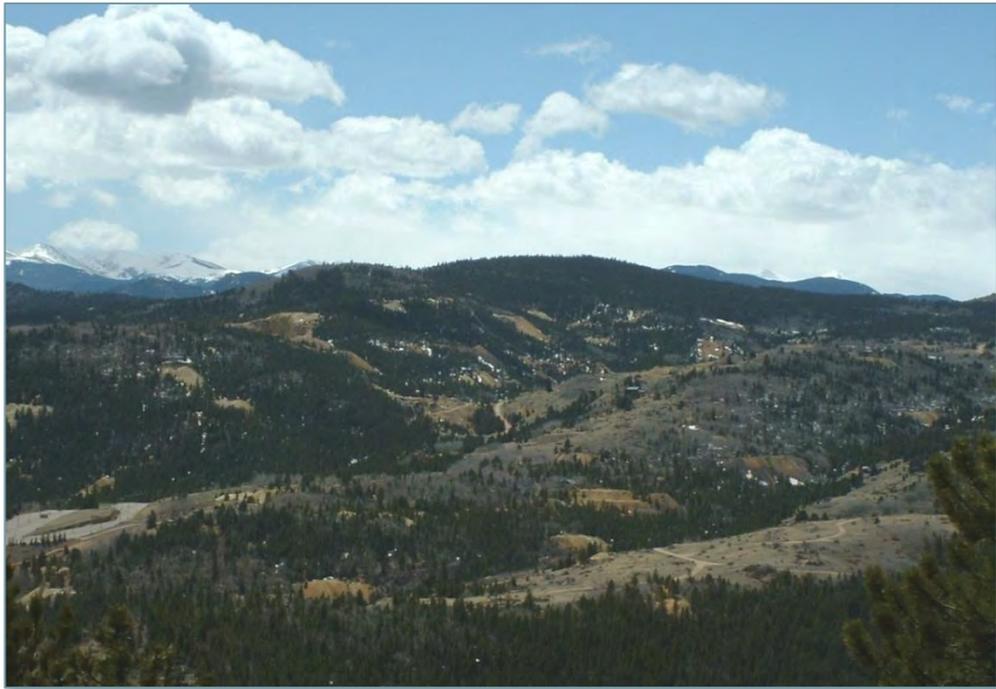
Figure 1-2. In this southwest overview, Nevada Gulch is at center, Quartz Hill stands behind, and Nevada Hill is center-right. The Continental Divide is in the background.

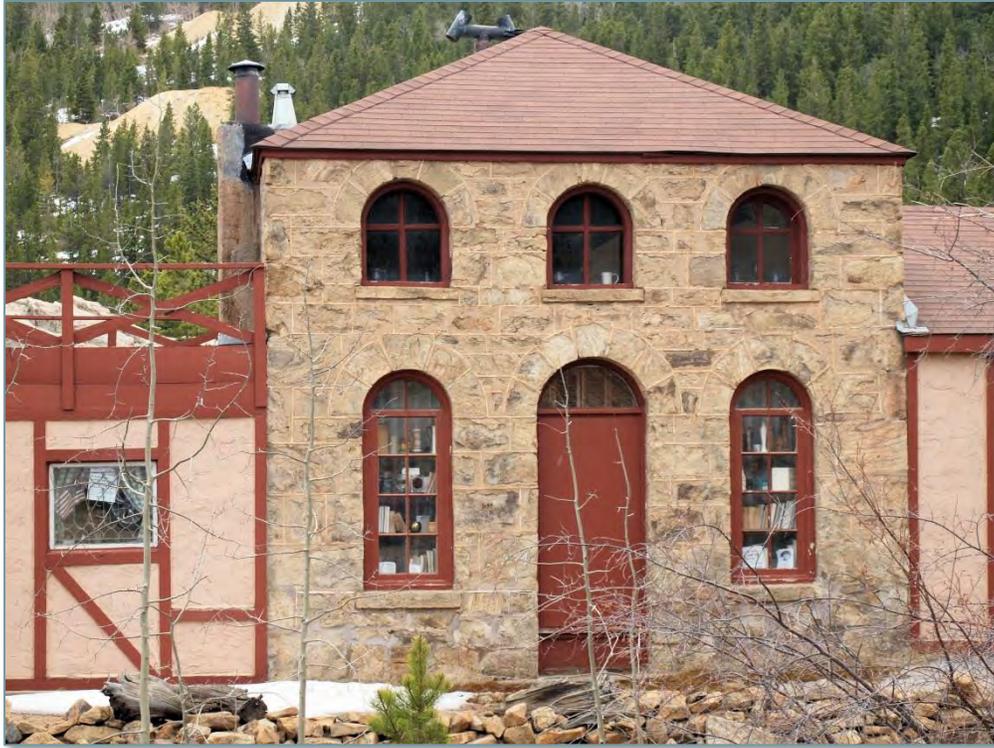
Figure 1-7. The only building remaining in “Dogtown” or eastern Nevadaville may not have originally served as a dwelling.

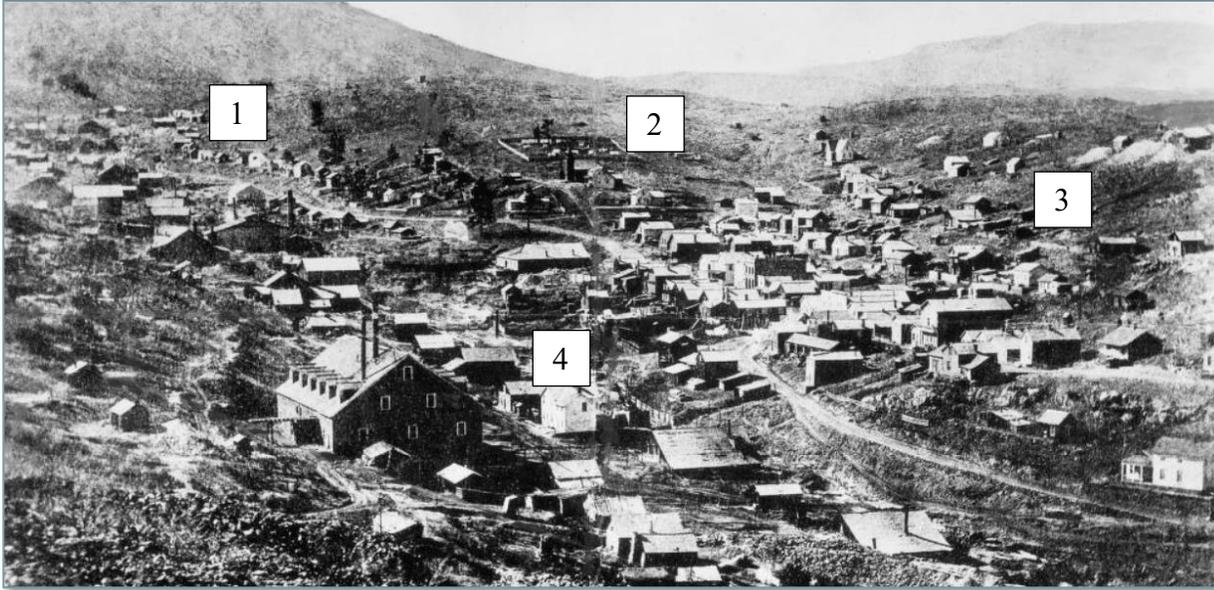
Figure 1-8. Early photograph showing: (1) the extent of development on far west Main Street; (2) a cemetery and dwellings at west end of Main Street; (3) dwellings north of Main Street/south slope of Nevada Hill; (4) mining structures & houses on the north side of Quartz Hill. The east edge of town is not visible. (*Source:* Denver Public Library, Western History online digital collection, X-11268, ca. 1870).

In addition to the stone walls, streets, and buildings, another important historical cultural landscape feature was the town cemetery. The first cemetery in Nevadaville was originally located just west of the commercial district on a rise overlooking over the town (see the area surrounded by a fence in Figure 1-8.) This is corroborated by an 1879 deed for 5GL.7.342, that noted the property boundary started "at the North east corner of the Grave Yard in said Nevadaville . . ." Later deeds for this same property were changed to state that the property boundaries started at the northeast corner of the "old graveyard," indicating that this first cemetery was no longer used. Although histories of Nevadaville do not record

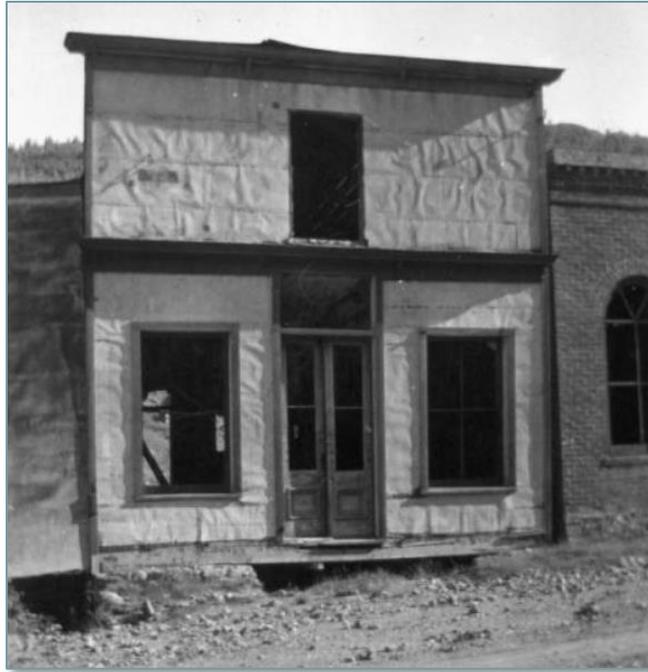
Figure 1-11. The frame Silver Dollar Saloon, with the brick Bon Ton Saloon adjoining on the right, were abandoned by the 1930s. (Source: Denver Public Library, Western History online digital collection, X-12474, ca. 1934-1937?).

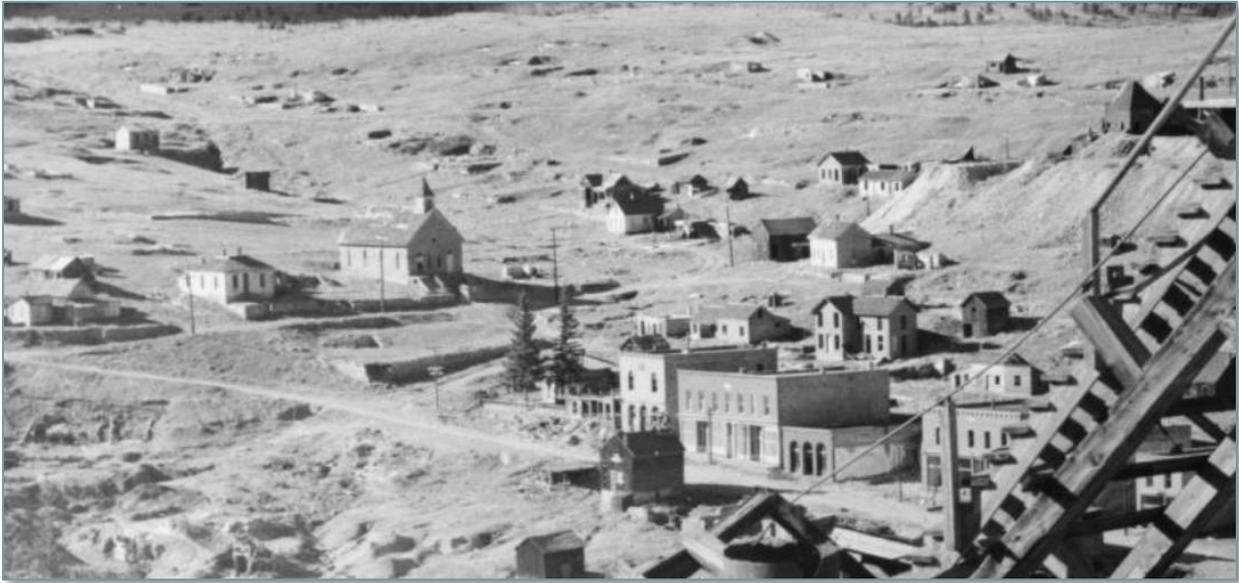
Figure 1-12. Photograph from 1940, showing the remnants of the once-thriving town. (*Source:* Denver Public Library, Western History online digital collection, K-428).

The physical decline of Nevadaville was recorded by several photographers in the mid-twentieth century. These photographs, available online at the Denver Public Library, show the dramatic loss of buildings from 1900 through the 1940s and later. The brick Methodist Episcopal Church on King Street, often a favorite subject for the photographers, was demolished in 1956. Today, however, a few houses have been rehabilitated in recent years, including the Gest House, the Reseigh House, and the Rice-Andrews-Paul House. There are a few year-round residents in spite of lacking potable water, and the Nevadaville Masonic Building is still used occasionally for meetings.

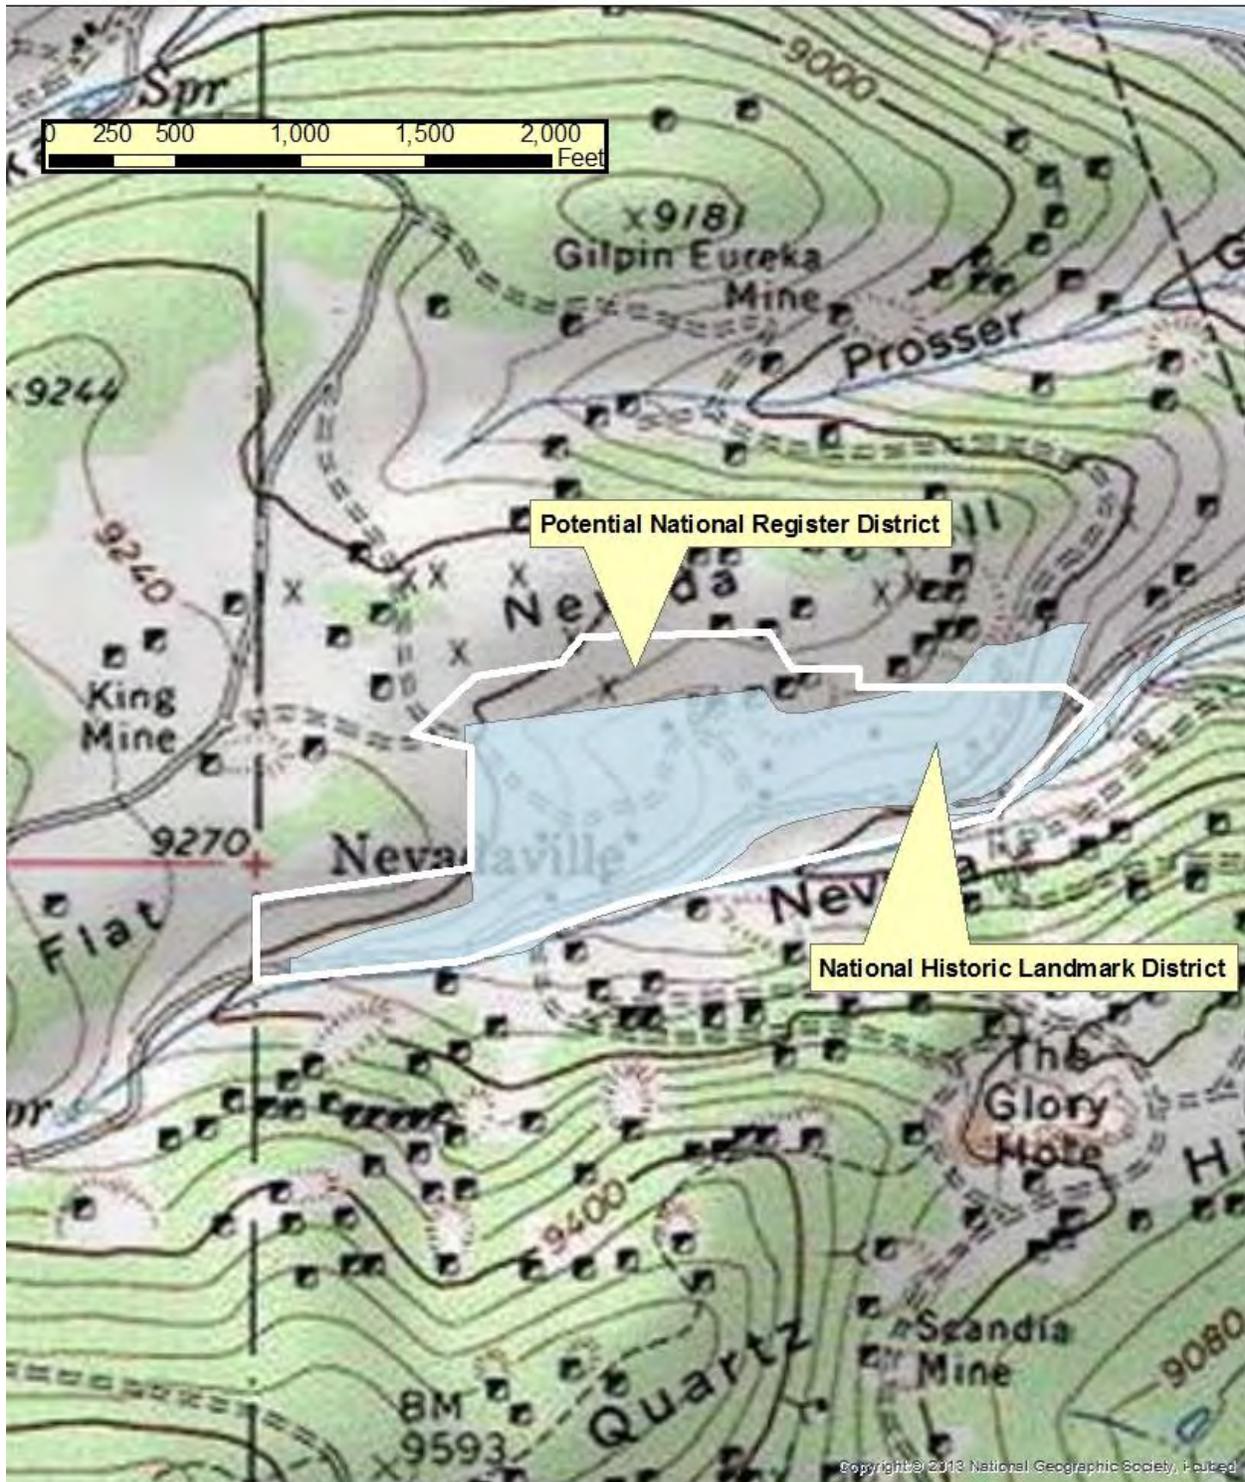
Figure 1-14. The white boundary outlines Nevadaville’s actual historic footprint based on archaeological features such as building platforms and foundations. The real footprint is larger than the area recognized by the current NHL, depicted as the faded blue block. The archaeological features within the real footprint clearly convey the townsite’s full size, content, and design. The outline could serve as a new National Register district boundary encompassing the full townsite. The potential new townsite National Register district would be an alternative to the landscape district above in Figure 1-13, should the landscape district be impossible to designate.

Nevadaville alone could be designated as a smaller National Register district, also based on a cultural historic landscape. The 2015 inventory accounted for the townsite's standing buildings, which represent only a fraction of its actual footprint. In fact, at least one hundred commercial and residential buildings extended in all directions. The buildings are gone, but are clearly conveyed by archaeological features including platforms, rock walls, and foundations. Figure 1-14 outlines the archaeological features confirming the footprint of the town site of Nevadaville. This footprint could serve as the basis for a National Register historic district. Further consultation with OAHP staff is essential for devising a district based on archaeological features.

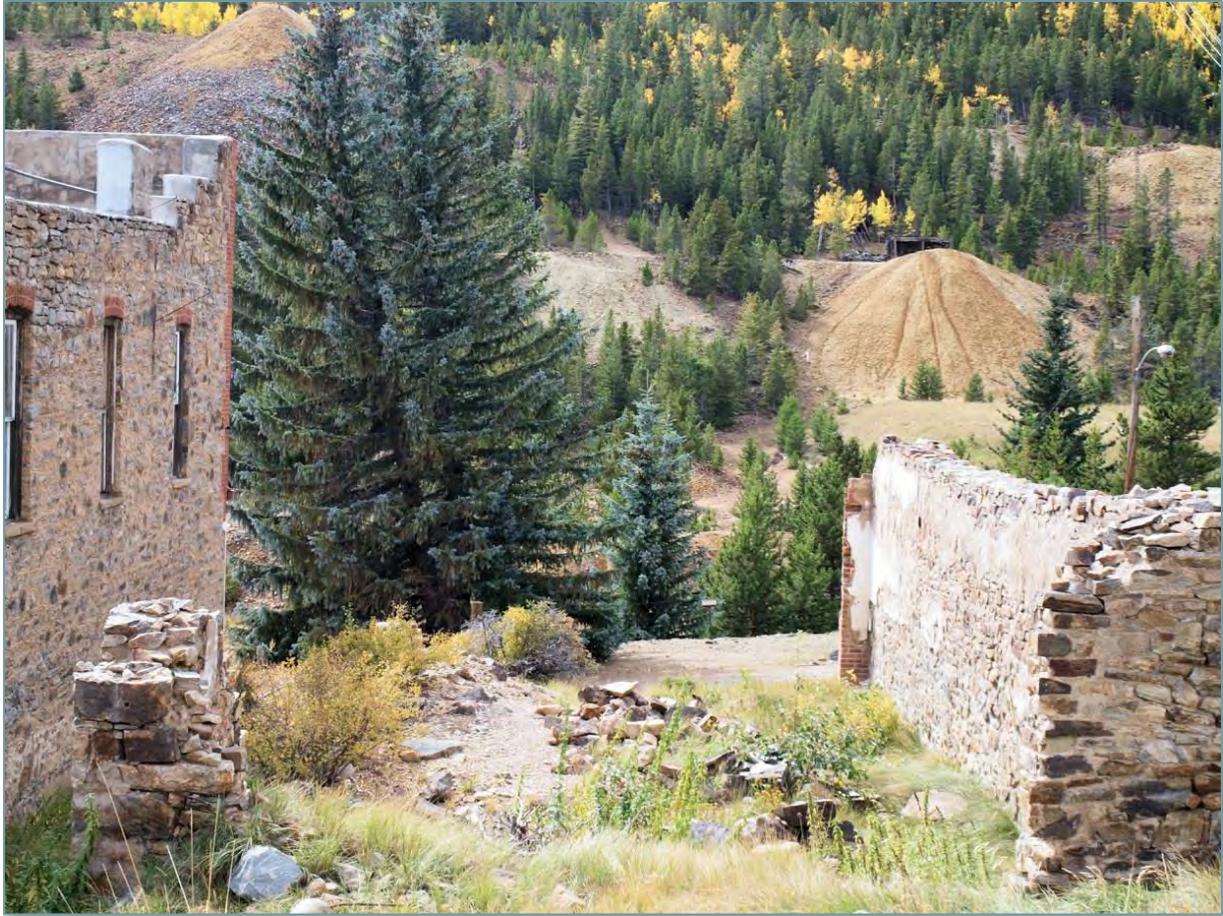
Figure 1-15. Ruins of historic buildings and mining resources are important elements of Nevadaville’s cultural landscape, and should be included in future district designations.

- Stabilize threatened buildings, structures, and large-scale archaeological features such as rock walls. Many of Nevadaville's buildings suffer deficiencies, while nearly all the mining buildings and structures are critically dilapidated. Action is timely. The current survey identifies all of Nevadaville's buildings but only a sample of those elsewhere in the gulch.
- Conduct additional survey to account for additional buildings and structures.
- Draft a comprehensive list, with buildings and structures ranked according to need, cost, and likelihood of property owner consent.
- Explore funding sources.

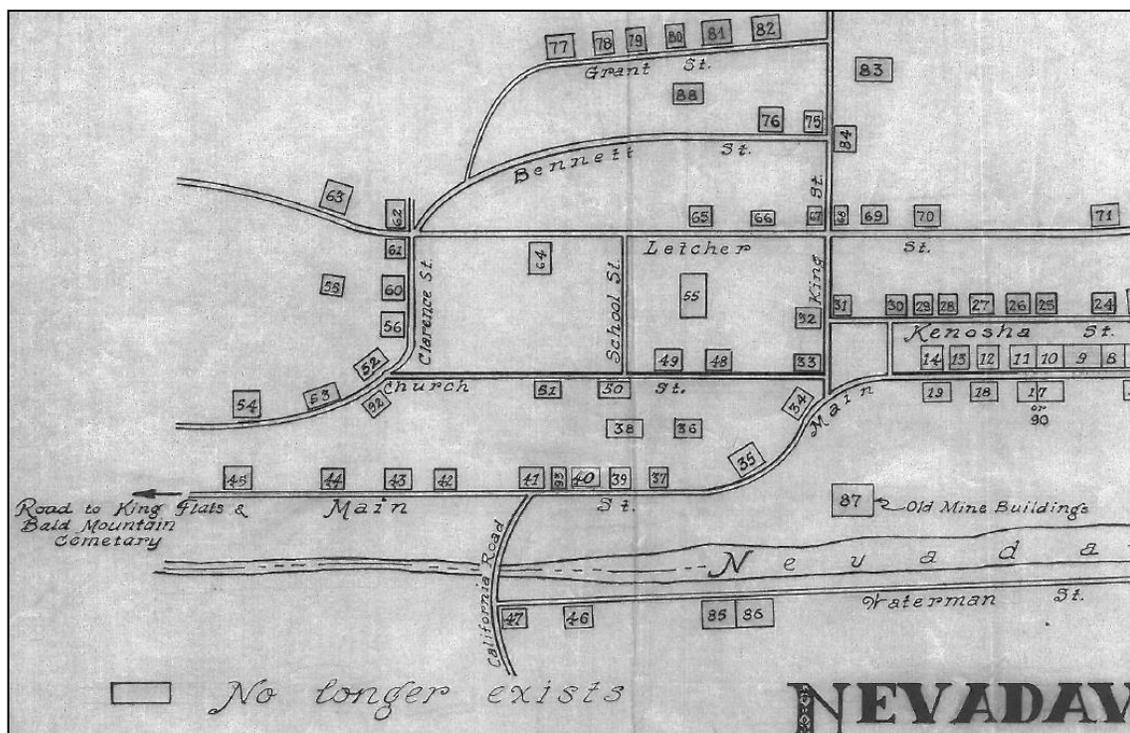
Figure 2-2. A portion of the historic numbering map of Nevadaville, copied in 1975 (date of original map unknown). The streets and buildings are not drawn to scale and are not in accurate locations.

In the early twentieth century, Gilpin County attempted to rectify the lack of clear property descriptions, and assigned each extant building standing a number from “0” to “95.” Although the exact date of the map in Figure 2-2 is unknown, deed research for this project indicated that it was in use at least from the 1930s. However, not all of the numbered buildings were in existence in the 1930s. The map continued to be used throughout the years, and Gilpin County added to the map. This is evidenced by the house built by Norman Palo; it was assigned Nevadaville Building #93 when it was built in 1974.

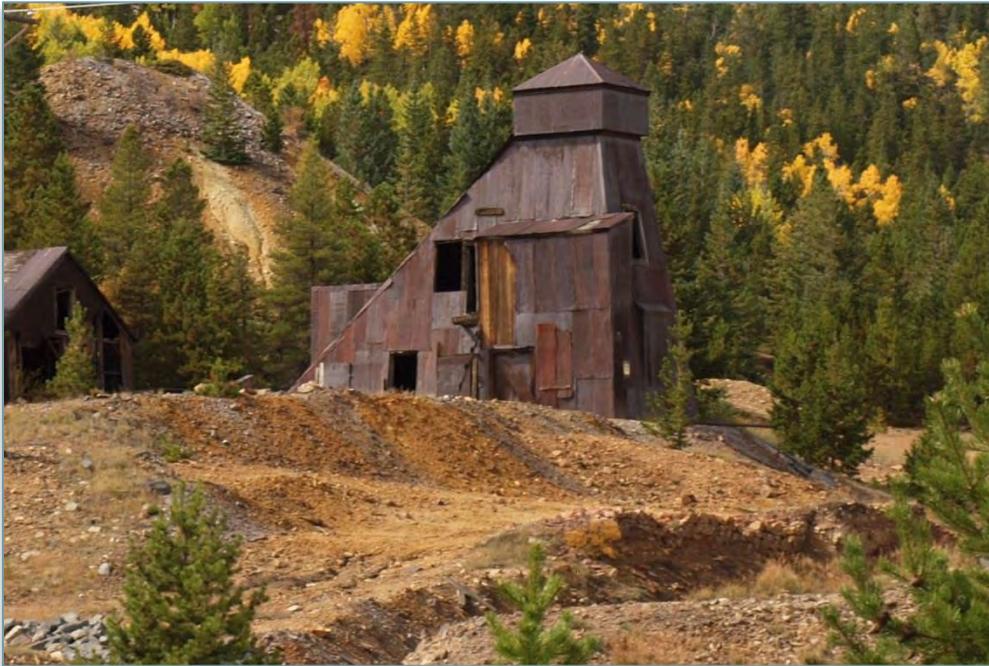
Figure 2-3. The Pozo mine, one of the best known and most photographed structures in Nevadaville, was not included within the boundaries of the 1991 National Historic Landmark District.

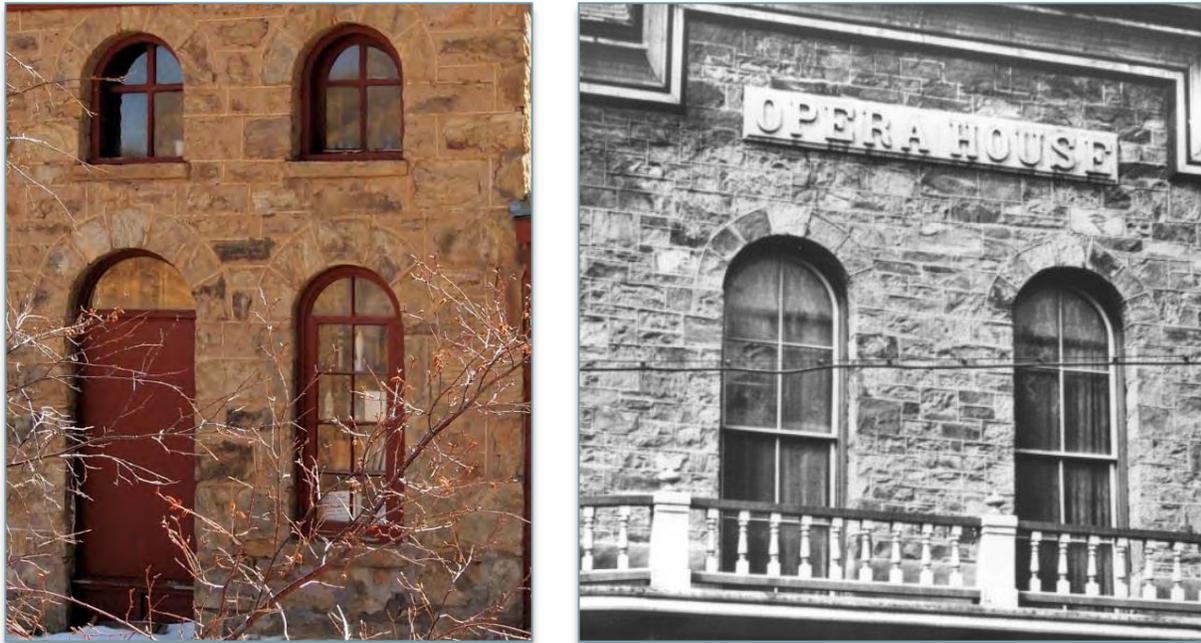
Figure 2-6. The Kevelin-Quackenbush house on the left (5GL7.332, N-1) and the Central City Opera house on the right many share similar masonry details, including stone size, finish, and beaded mortar. The Opera House was built in 1878 by Cornish miners, and the Kevelin-Quackenbush house was likely built at the same time according to deed research. It is the closest extant building to Central City on Nevadaville Road.

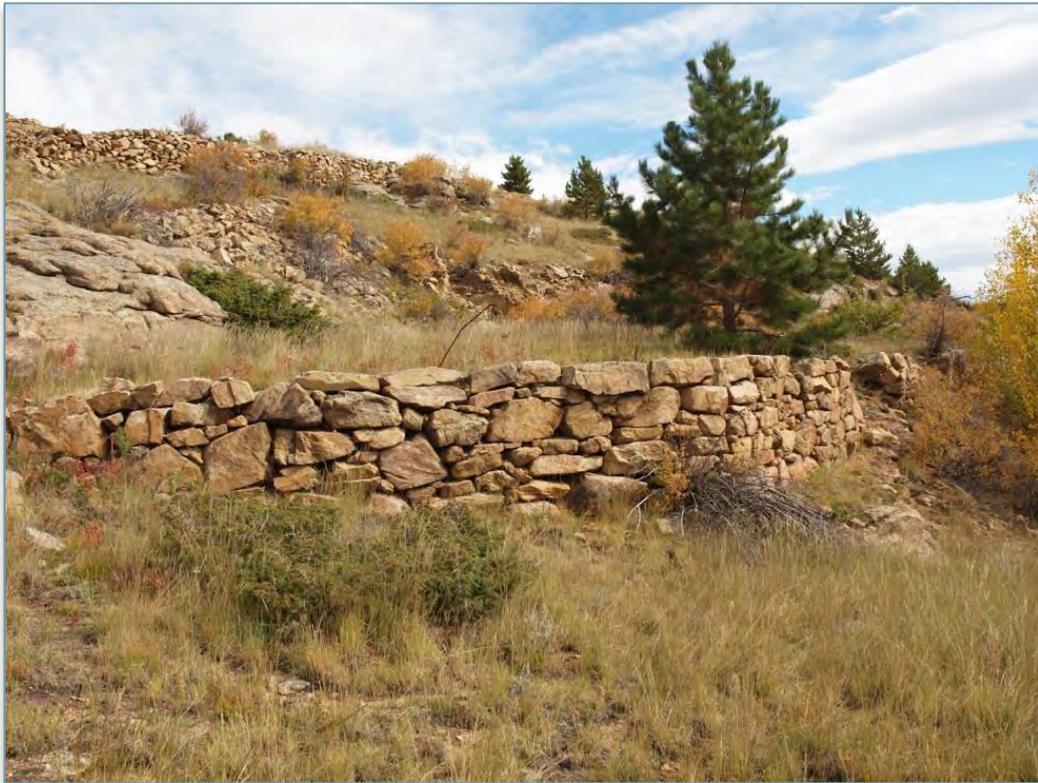
Figure 2-7. These stone retaining walls at the east end of Nevadaville show the tiered arrangement of Prize, Kenosha and Letcher Streets.

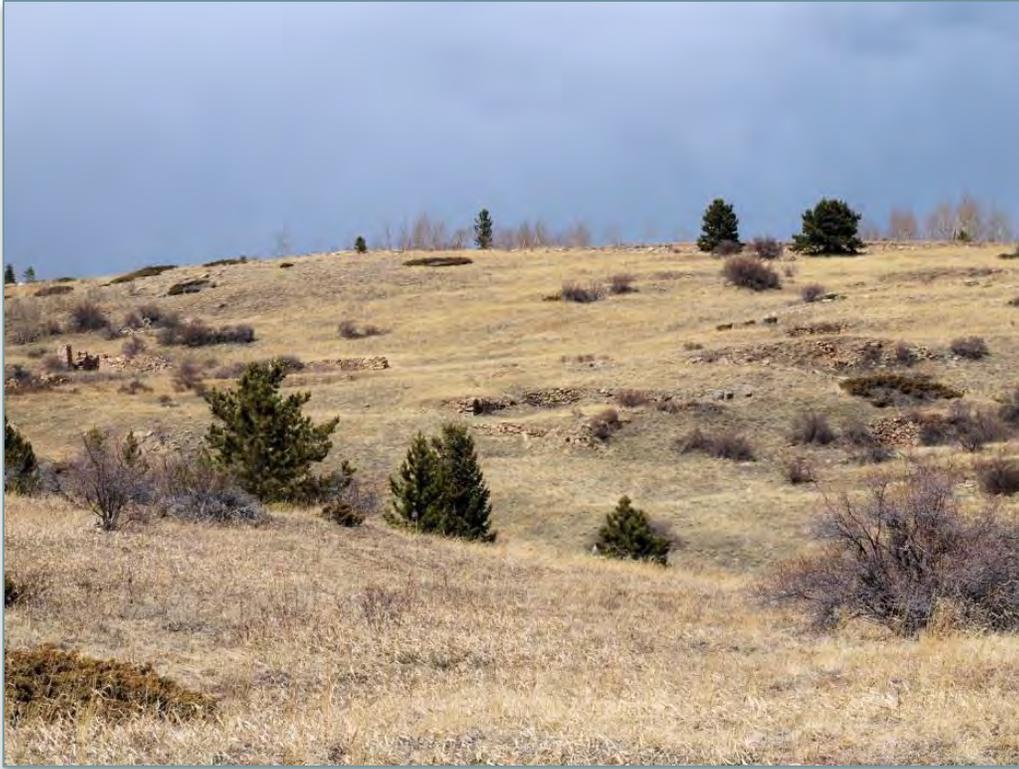
Figure 2-6. Numerous stone foundations dot the hillside on the northwest end of Nevadaville, on Letcher, Bennett and unnamed streets.

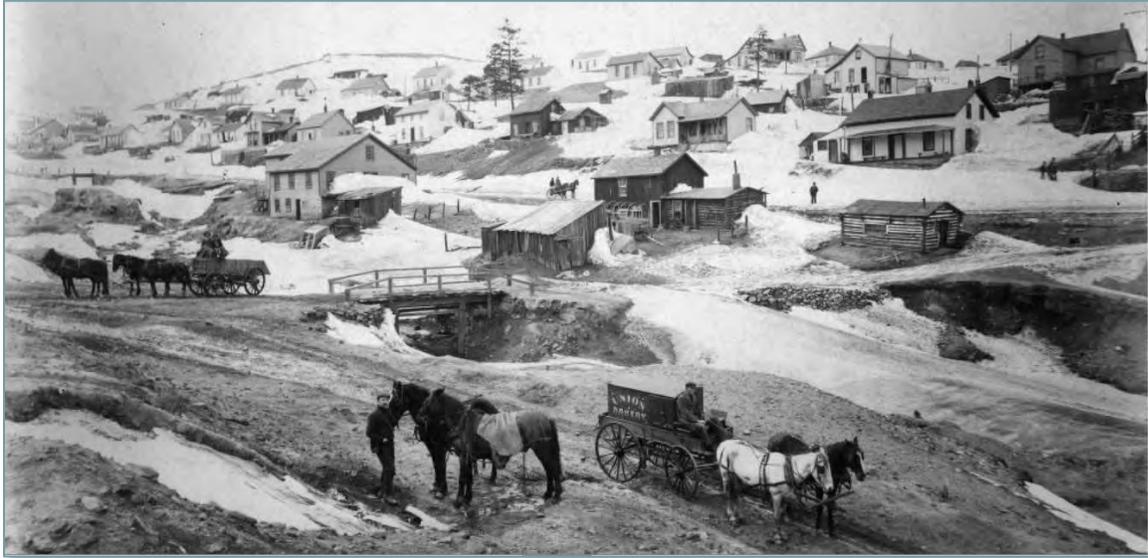
Figure 2-8. This view from 1889 of the west end of Nevadaville shows that the houses were primarily side gable, gable-front and wing, or gable-front vernacular dwellings. (Source: Denver Public Library, Western History online digital collection, X-11253, A.M. Thomas photographer).

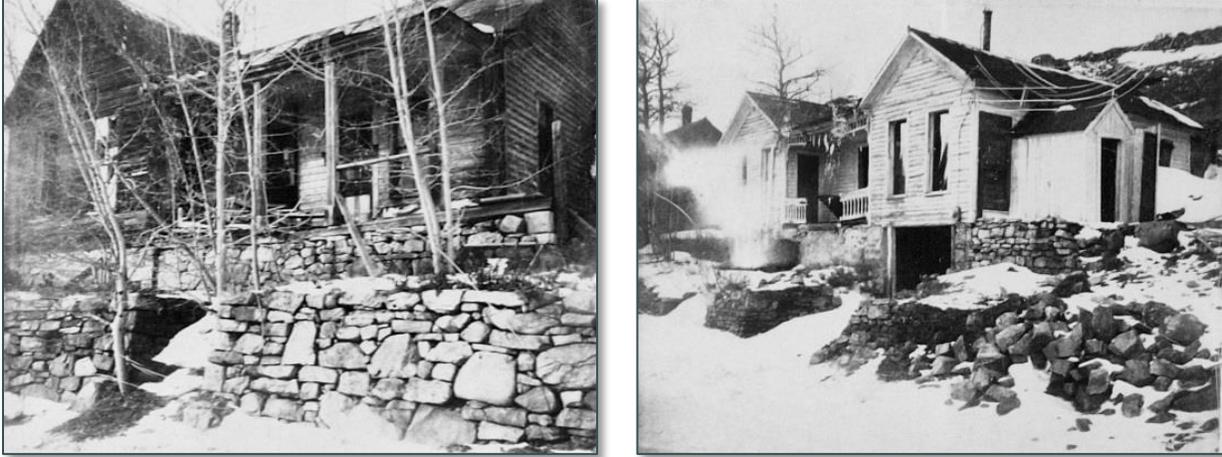
Figure 2-10. Residences on Prize Street. Left: 5GL.7.334, Right: 5GL.7.523.

Based on the records search, there are three properties that are either no longer extant, or for which no information currently exists. Two buildings on Prize Street (east and north of downtown Nevadaville) were demolished sometime after they were inventoried in 1986: 5GL.7.334 and 5GL.7.523.²⁹ The site form for 5GL.7.333 (also on Prize Street) was missing; therefore, its status could not be determined, although all other Nevadaville buildings listed in the 1991 NHL nomination were accounted for.

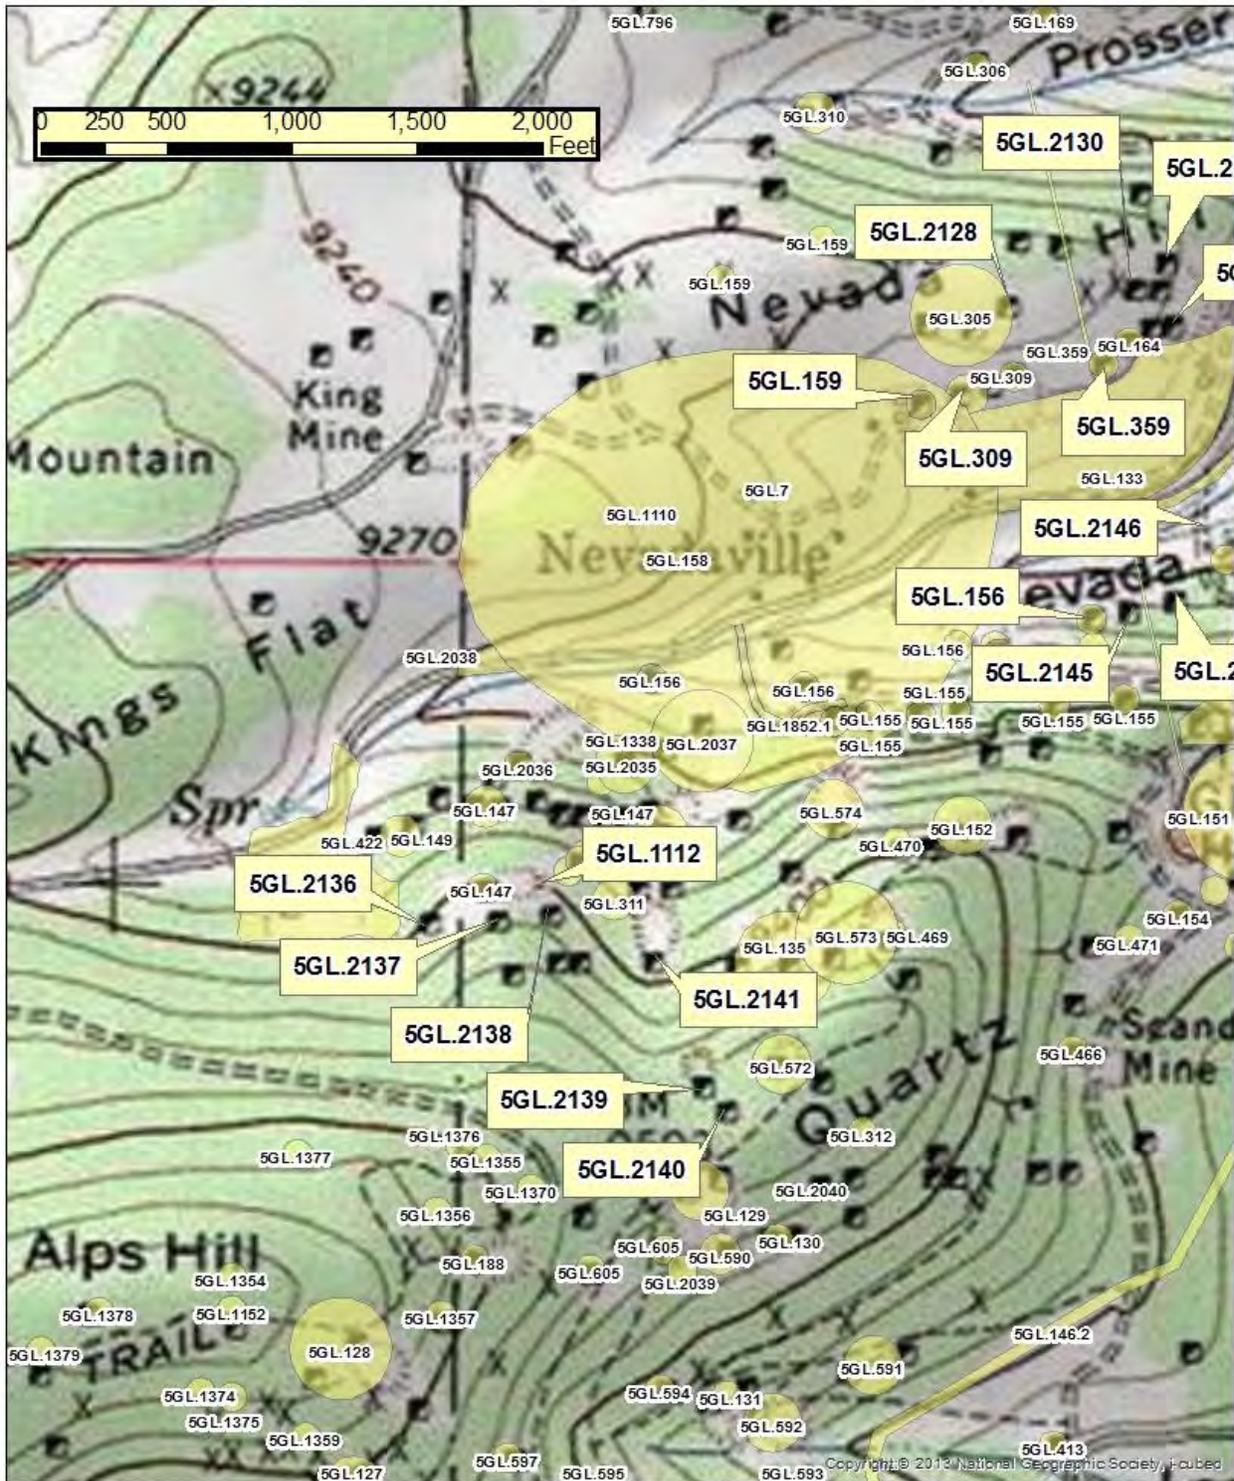
Figure 3.1: The index map, an enlarged, digital version of Central City (7.5') 1972, depicts resources inventoried in Nevada Gulch's western end. Inventoried resources are boldly flagged. Light-yellow circles with small numbers are all the previously recorded sites, a GIS overlay provided by OAHp. The map continues below as Figure 3.2.

Mountain States Historical recorded twenty-five mining resources scattered throughout Nevada Gulch. See Table 3.1 for a list by Smithsonian number, and Figures 3.1 and 3.2 for locations. Of the twenty-five resources, eleven were located on Nevada Hill's south side, which forms the gulch's north wall. Seven more were on the northeast flank of Alps Hill, on the gulch's south wall, and a final seven were on Quartz Hill's north flank, again on the gulch's south wall.

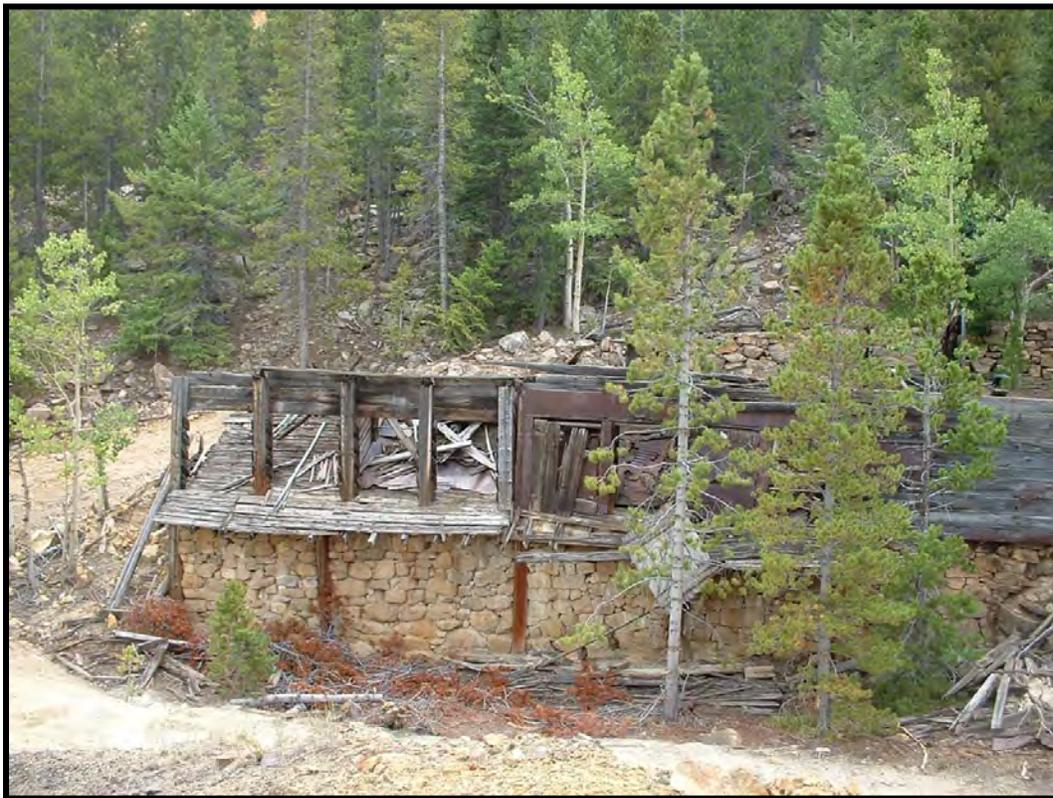
Figure 3.3 View southeast at the Kansas Mine's (5GL.156) ore bin (F4) and its expertly constructed rock walls.

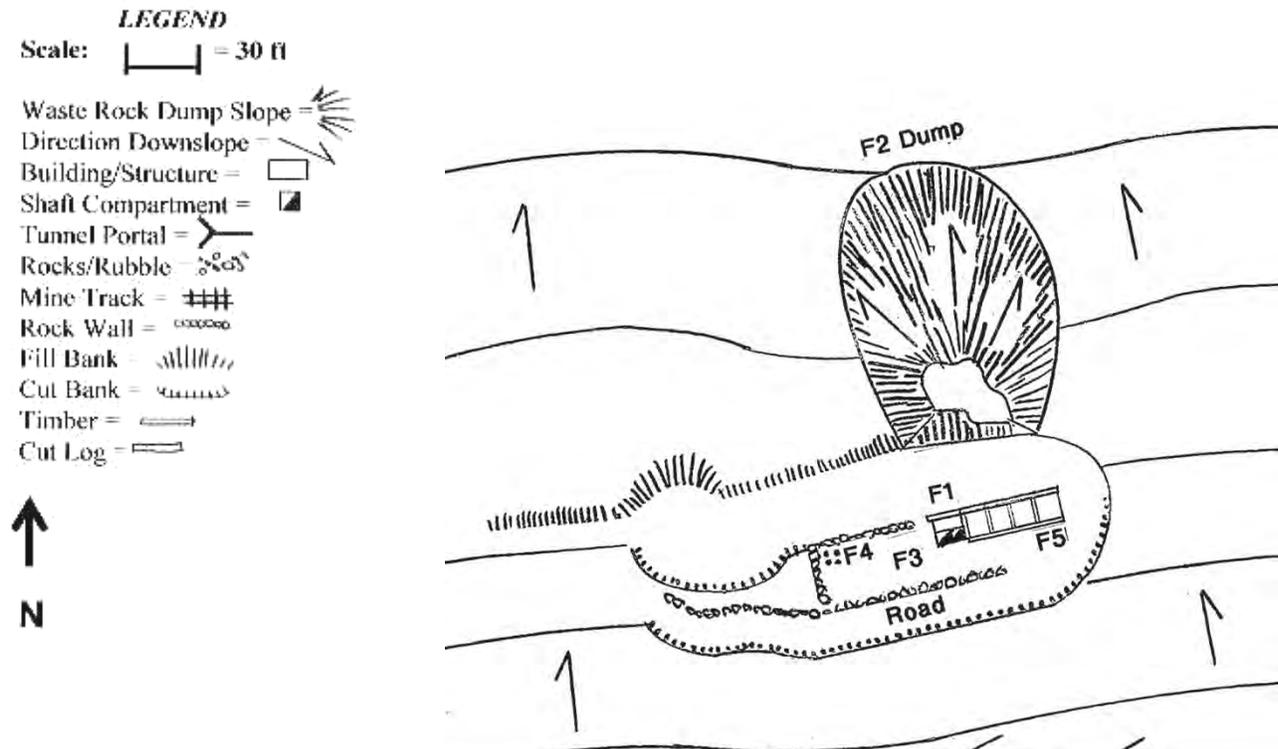
Figure 3.5 Site map of 5GL.156.

A foundation (F4) remains from the hoist, a single-drum steam unit 4'x7' in plan. The foundation features four anchor bolts in a brick pad, whose upper courses are gone.

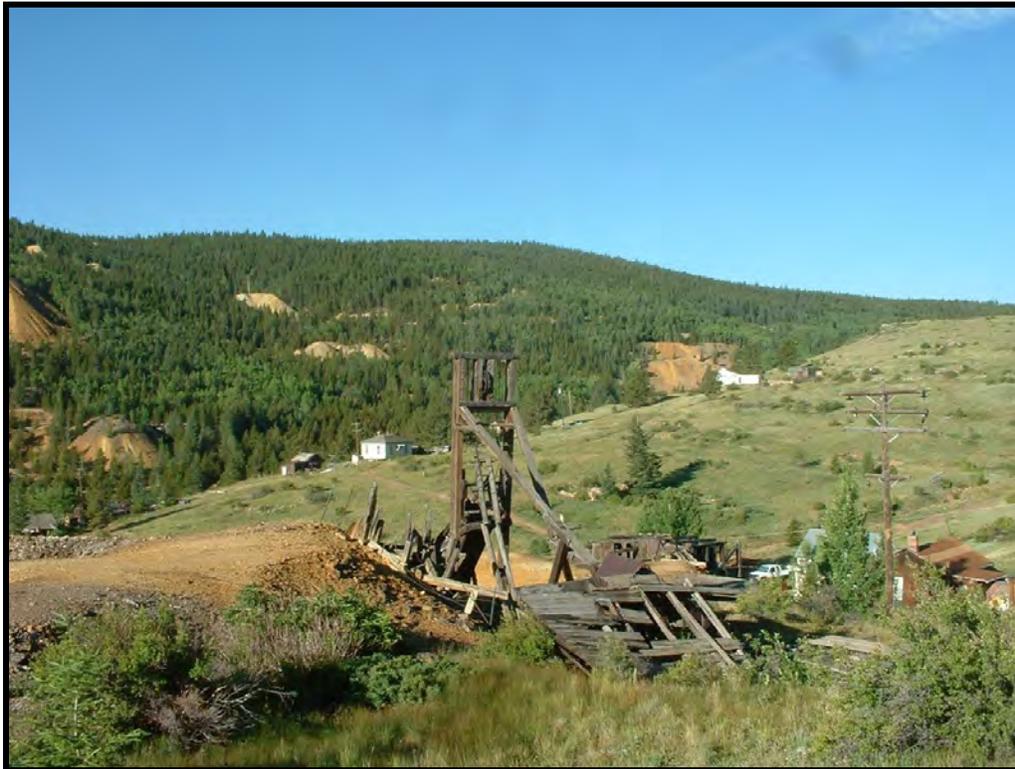
Figure 3.6 Southeast overview of the Hubert Mine (5GL.159), its standing headframe, and collapsed hoist house.

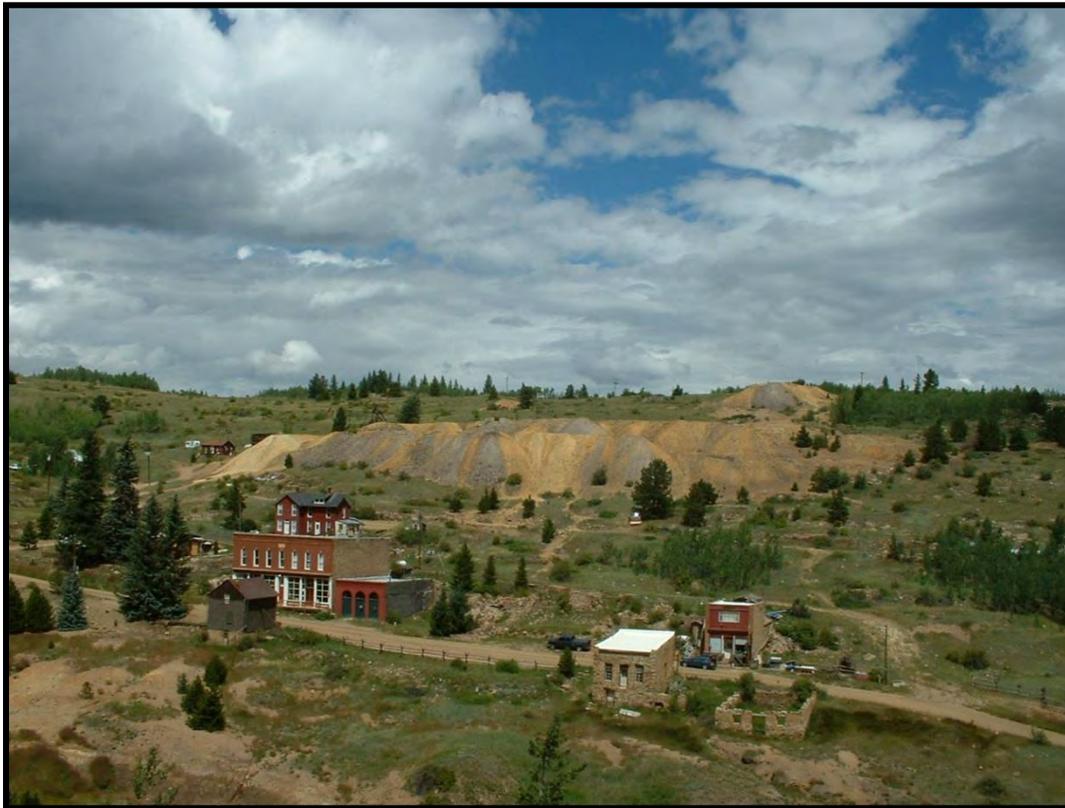
Figure 3.8 In the northwest overview, the Jones Mine (5GL.309) is the huge dump at center, contributing feeling to Nevadaville, below.

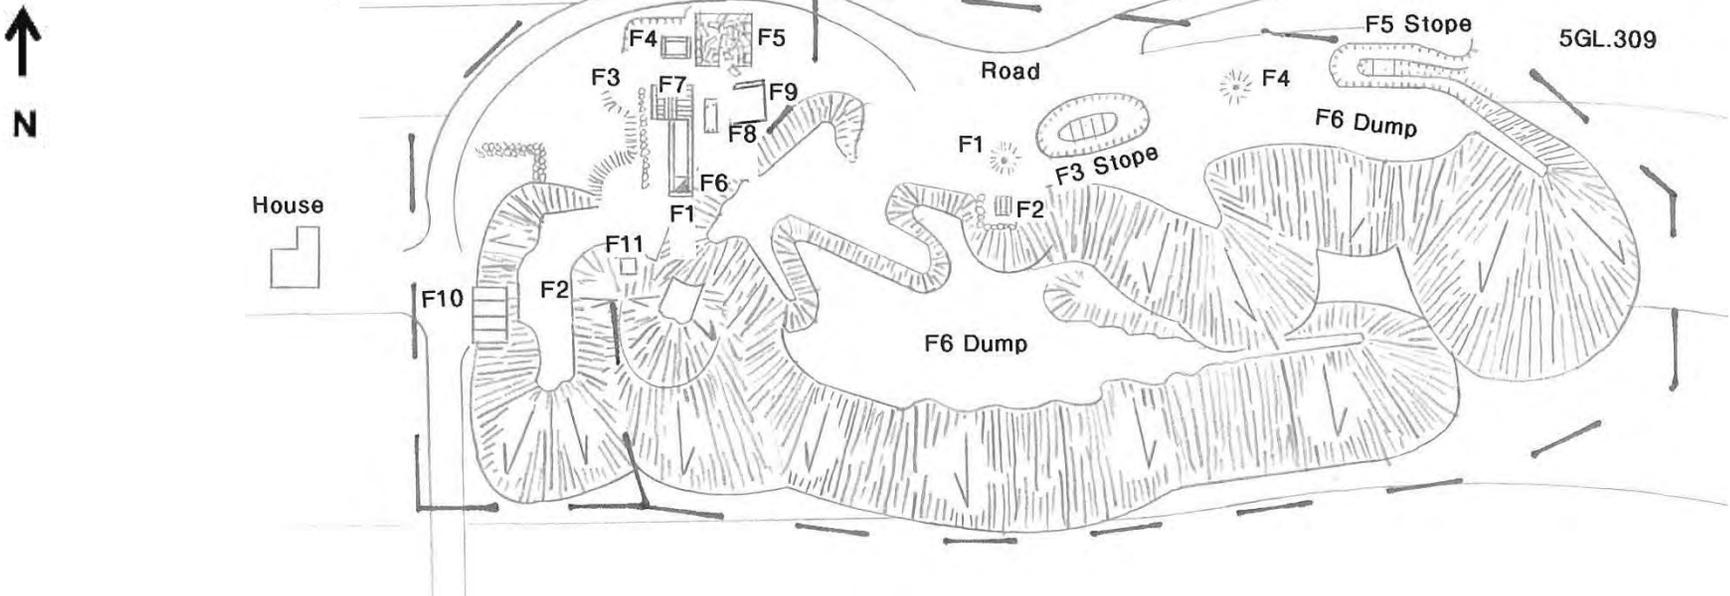
Figure 3.9 Site map of 5GL.309.

Working the vein from the top downward, miners incised two stopes (F3, F5) directly in the ground. The Division of Reclamation, Mining, and Safety (DRMS) capped them by digging out the openings and covering them with concrete panels, creating two craters 24'x45' and 20'x55' in area, respectively. In the past, a mining outfit developed deeper sections of the vein through two vertical shafts (F1, F4). DRMS closed these as well by bulldozing waste rock over concrete plugs, the shafts now being nearly indistinct. The western shaft features remnants of a shaft house platform and hoist foundation (F2), mostly destroyed during closure. The platform's

remaining portion is 11'x12' in area and outlined with dry-laid rock walls. The hoist foundation consists of 8"x8" timber footers 3½'x6' in plan. The dump (F5), the site's important element, is a bench 120'x390' in area and 18' thick.

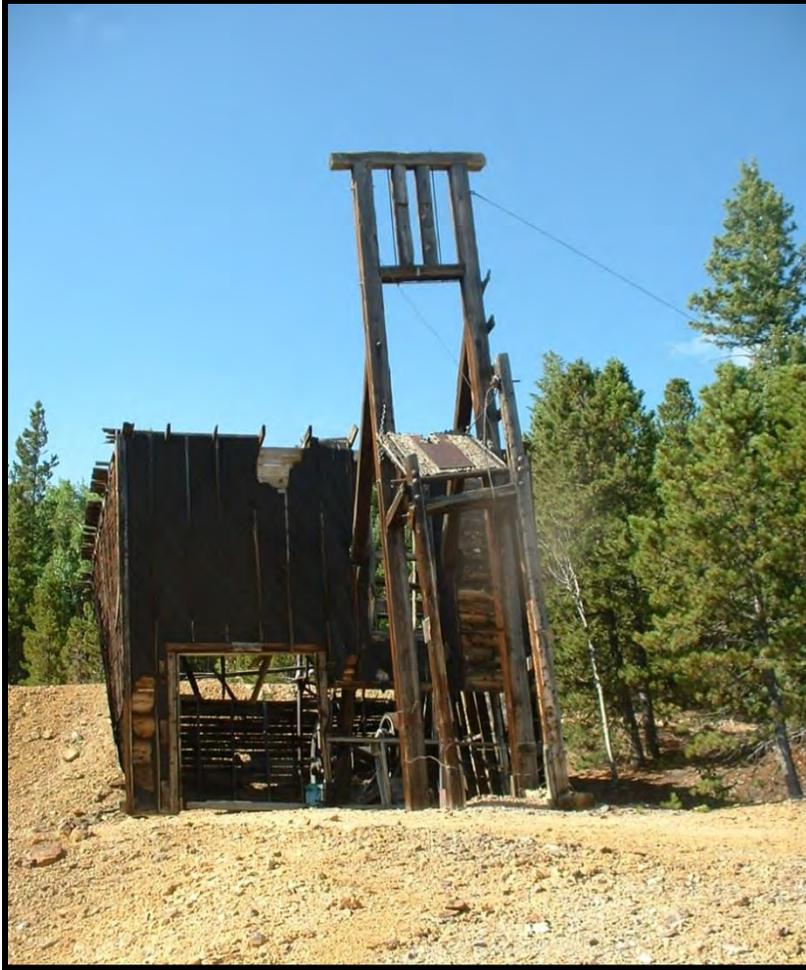
Figure 3.11 View south at the Flack Mine (5GL.1112). A two-post gallows headframe stands right of a hoist house, with its shed roofline and tall window for hoist cable (F2, F4).

The Flack Mine (5GL.1112) features an intact hoisting system including a headframe and gasoline hoist inside a hoist house. The assemblage clearly conveys the general design, content, and operation of mechanized hoisting systems, and their individual components. At one time, hoisting systems were found by the dozens in Nevada Gulch. The Flack, as well as several other mines excluded from the inventory, have the only surviving examples. Significance is local.

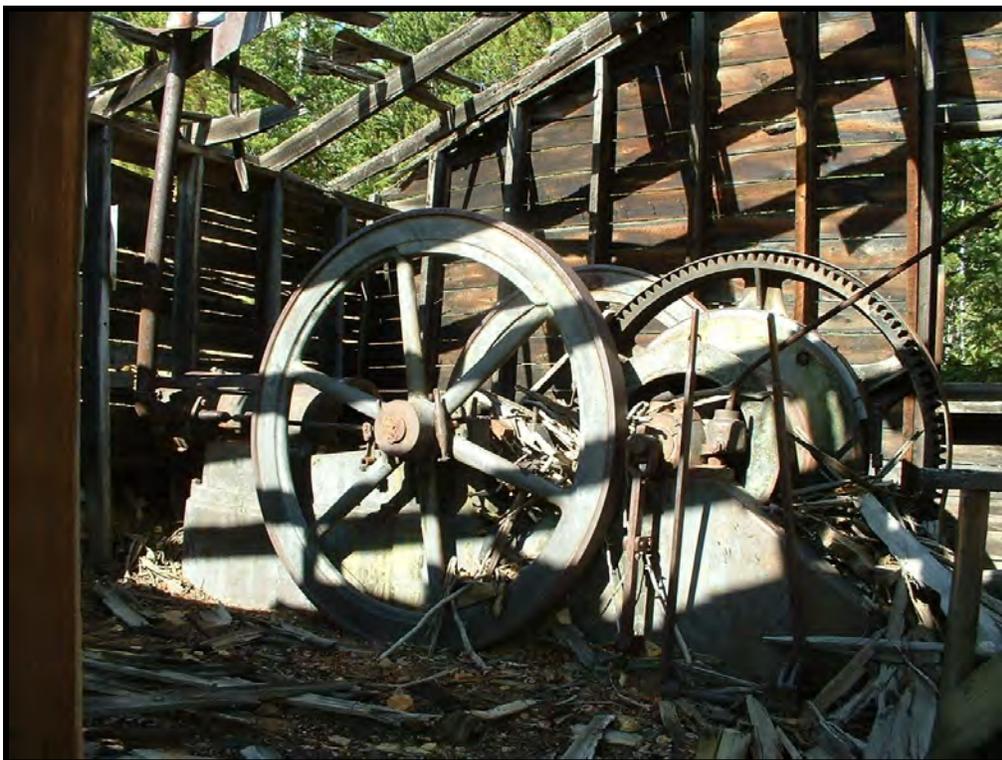
Figure 3.12 West view of the Flack Mine's (5GL.1112) hoist, a single-cylinder gasoline model.
