Nevadaville Historic Resources Survey: Phase I
SURVEY REPORT
June 2015

Nevadaville Historic Resources Survey: Phase I 2014-2015

Survey Report June 2015

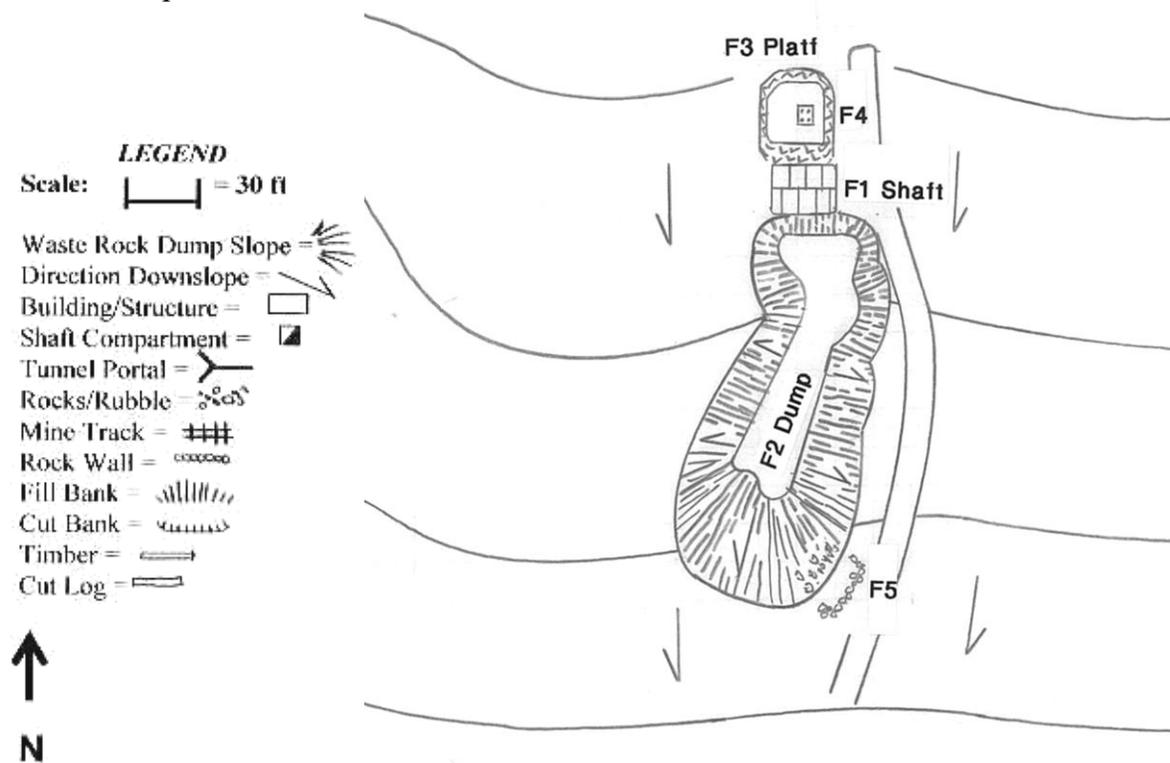
Figure 3.13 Site map of 5GL.2128.

graded the top-surface flat for ore car tracks, which are gone. The hoist house platform north of the shaft is a distinct and preserved pad (F3) 18'x20' in area and 3' thick. Only light structural debris reflects the hoist house, no clear footprint or foundations being evident. A large foundation (F4) does, however, represent the hoist. The foundation is a rectangular cluster of mortared rocks 5½'x6' in plan with a perimeter of anchor bolts. The footprint indicates that the hoist was a single-drum steam unit. The boiler and shop were near the hoist, but no small-scale features remain from them. A platform with low rock wall (F5) 18'x24' in area represents the ore bin, at the waste rock dump's southeast toe.

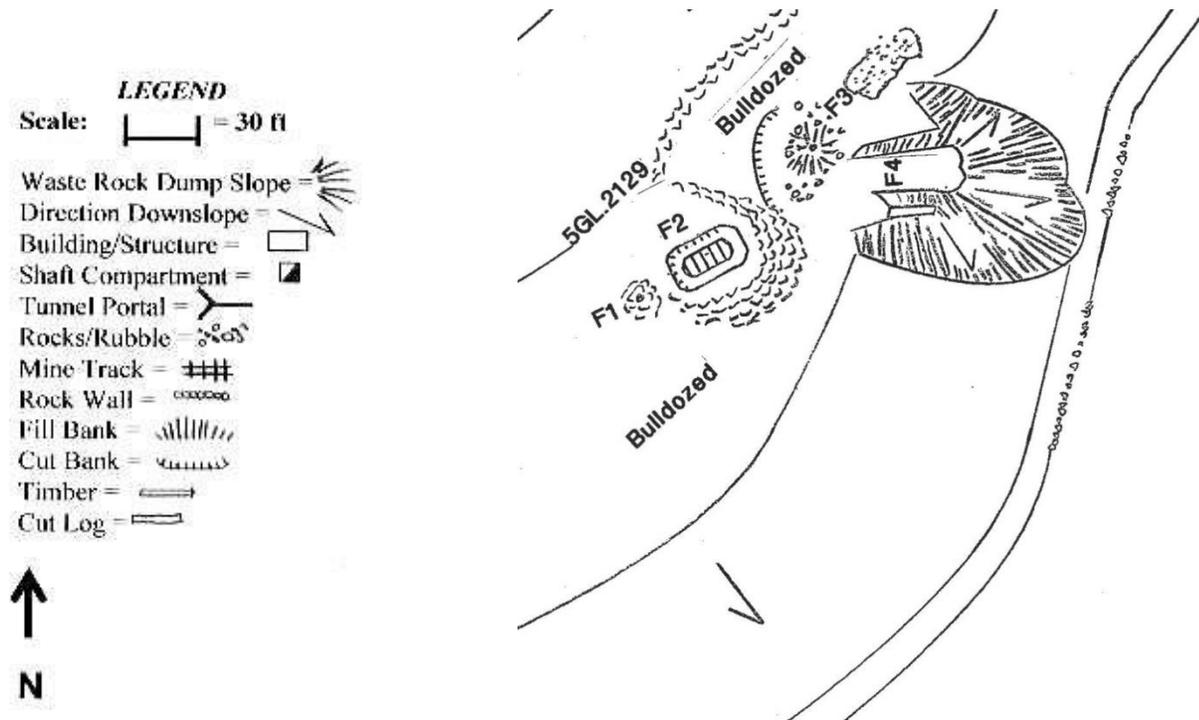
Figure 3.14 Site map of 5GL.2129.

30' in diameter also with a monument. The stope is a rectangular depression 22'x33' in area with concrete panels at bottom. The dump is a disorganized, hummocky mass 10' thick with some original profile.

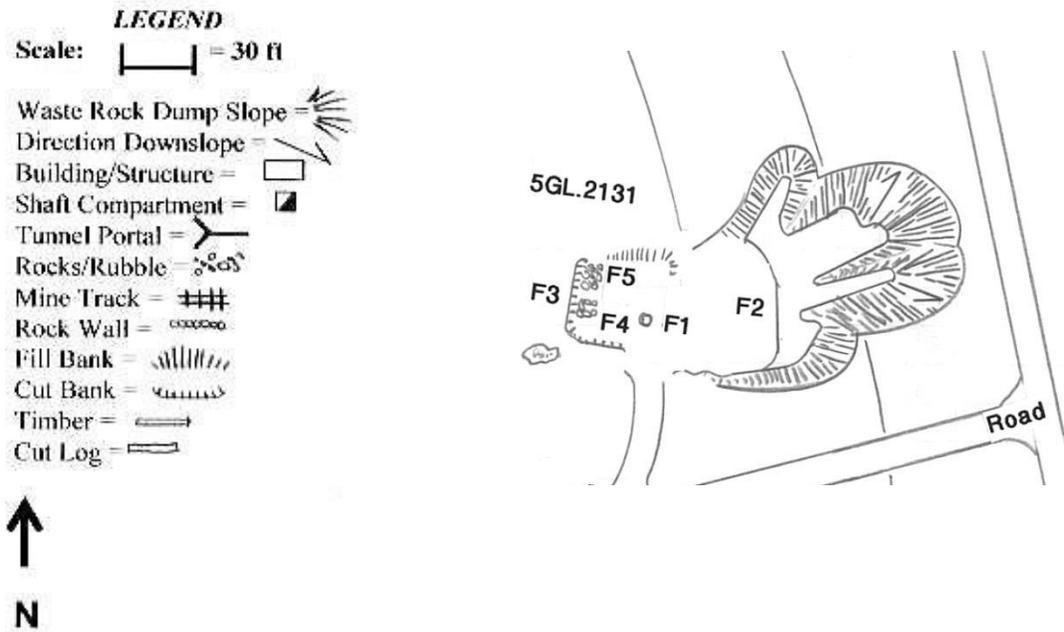
Figure 3.16 Site map of 5GL.2131.

The Golden Treasure Mine was a shaft operation on a vein by the same name crossing east-west through Nevada Hill's east shoulder. Today, site is an archaeological example of a shaft mine, the resource type. Developed during the 1870s, the Golden Treasure featured a shaft house enclosing the shaft collar, steam hoist, boiler, and shop. All buildings, structures, and equipment were removed long ago, and DRMS capped the shaft during the late 1980s, leaving an assemblage of archaeological features.

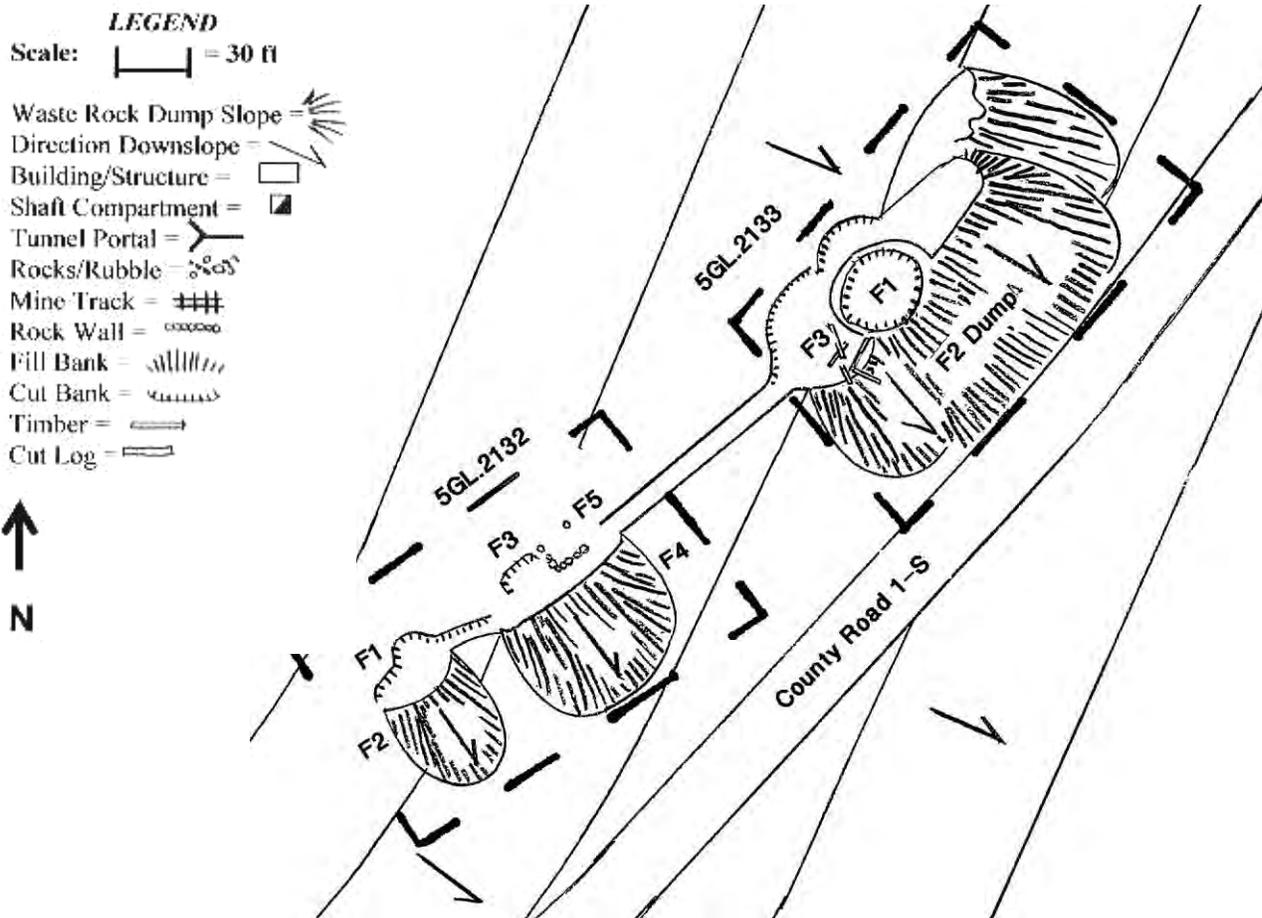
Figure 3.17 Site map of 5GL.2132.

The site was a simple prospect shaft on the Dyke Vein, trending northeast across Nevada Hill's southeast flank. The vein was developed through the larger Dyke Mine (5GL.2133) to the east. Both sites are within Nevadaville's eastern suburb, represented by residential building platforms above and below. The site's two waste rock dumps are visible from County Road 1-S, passing a short distance south and below. All buildings and equipment were removed long ago, leaving only two shafts, their waste rock dumps, and a platform for a shaft house.

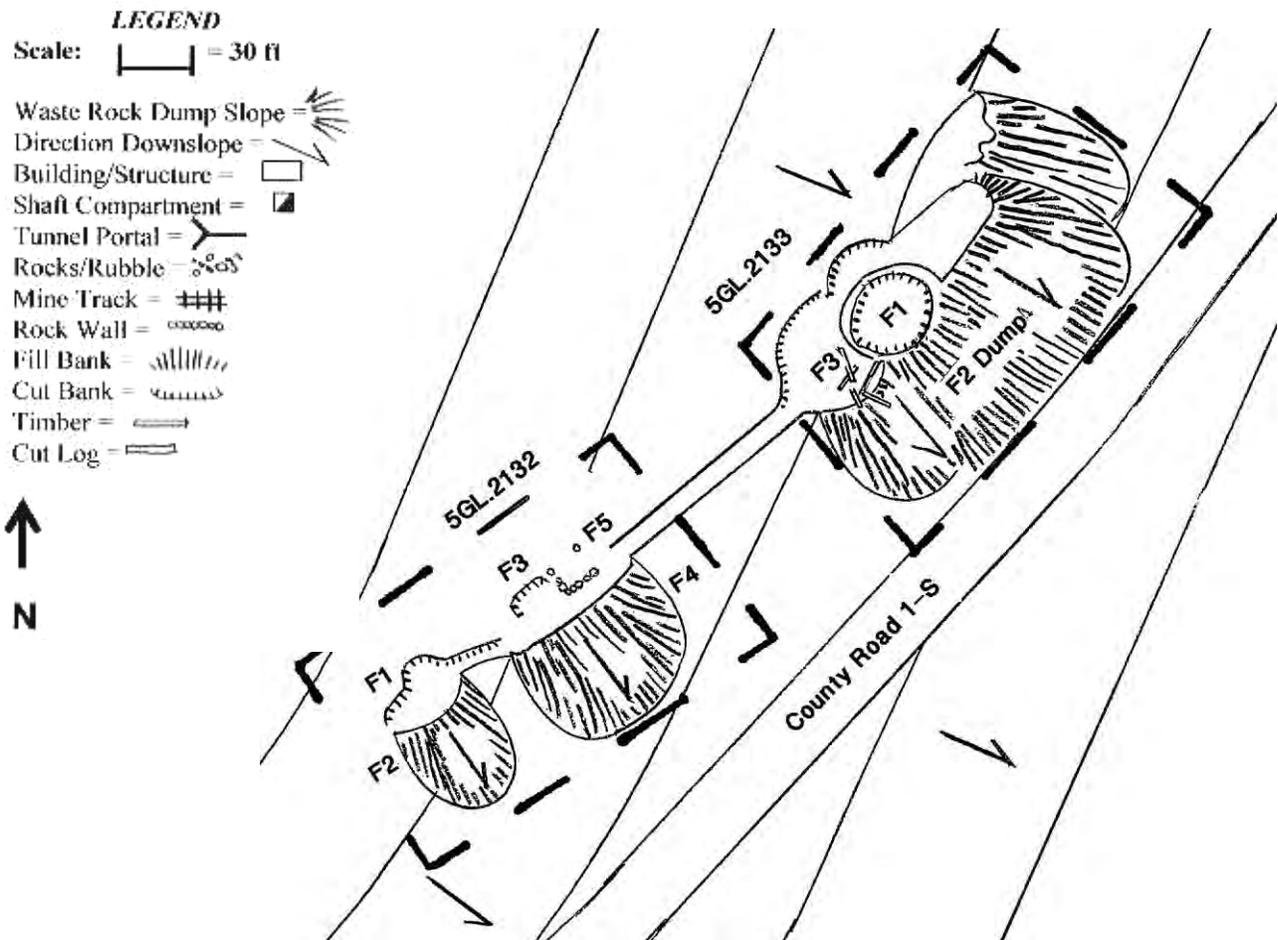
Figure 3.18 Site map of 5GL.2133.

The Dyke Mine was a shaft operation on a mineralized vein trending a short distance northeast across Nevada Hill's southeast flank. The vein was initially prospected through a prospect shaft adjacent and west (5GL.2132). Both are presently within Nevadaville's east boundary, with a few residential building platforms retained by rock walls surrounding the site. County Road 1-S, the only route connecting Nevadaville with Central City, passes immediately below and south of the site. The waste rock dump is a prominent landmark on the roadside.

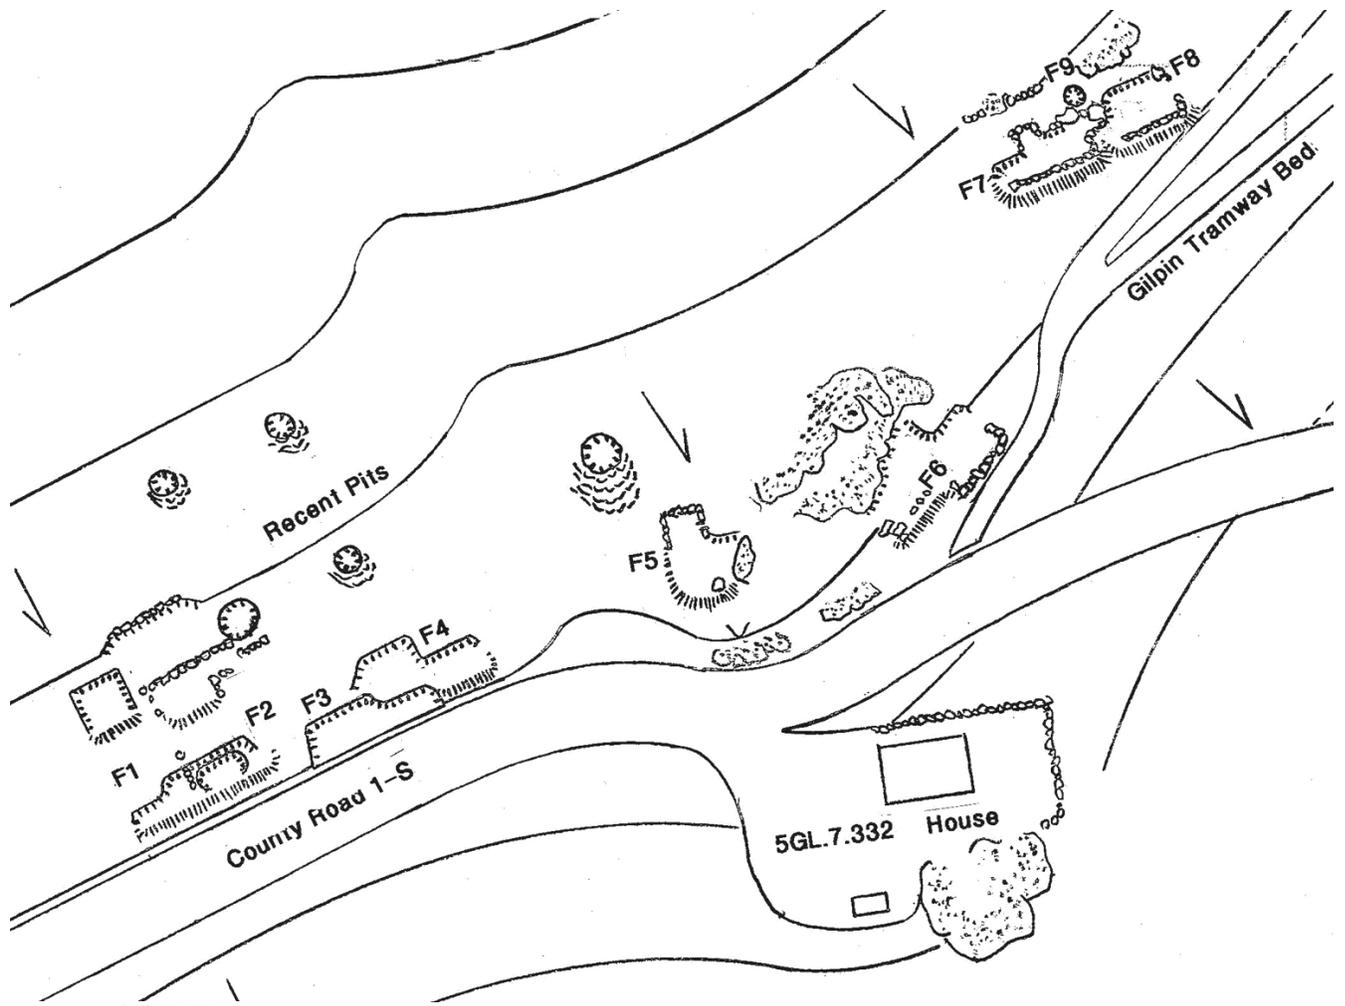
Figure 3.20 Site map of 5GL.2135.

A complex platform (F2) remains from the western building's neighbor. The platform features three tiers totaling 40'x80' in area, the building's size. The lower is 36'x40' in area with a cellar pit at center and rock wall 3' high holding back the cut-bank. The pit is a depression 12'x16' in area and 2' deep. The center tier, 4' above the lower, is a small offset bench 10'x13' in area retained by a dry-laid rock wall. The upper tier, 4' higher still, is 25'x40' in area with walls retaining the fill- and cut-banks. A cellar pit 9' in diameter and 5' deep is on the east edge. Sod has overgrown the platform but small artifacts including cut nails, tableware and bottle fragments, and hardware are scattered around. Buried deposits are unlikely because steep slopes are a poor deposition environment.

The third building stood on a well-defined platform (F3) 15'x34' in area, incised into the county road's cut-bank. The platform is blanketed with sediment and overgrown with sod, concealing all artifacts except for a few cut nails and bottle fragments. Additional small artifacts are probably buried underneath the surface.

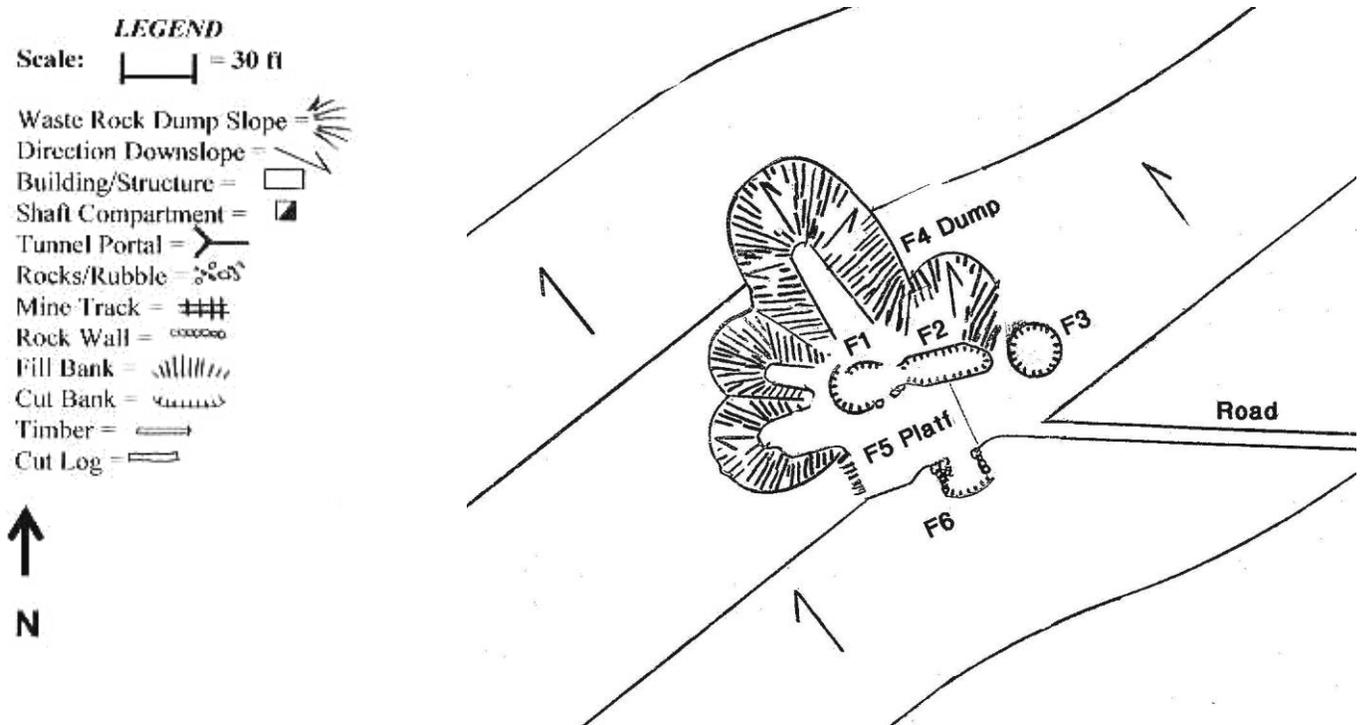
Figure 3.21 Site map for 5GL.2136.

The Barker is an archaeological example of a shaft mine, the resource type. The Barker Vein was discovered in 1860, the mine yielded a little ore through a main shaft during the decade, and was developed to a depth of 200' during the 1870s. The site is amid thick doghair fir forest on Alps Hill's steep northeast flank. All buildings, structures, and equipment were removed long ago, leaving an assemblage of archaeological features. A main shaft, slit-like stope, and secondary shaft were aligned east-west on the vein.

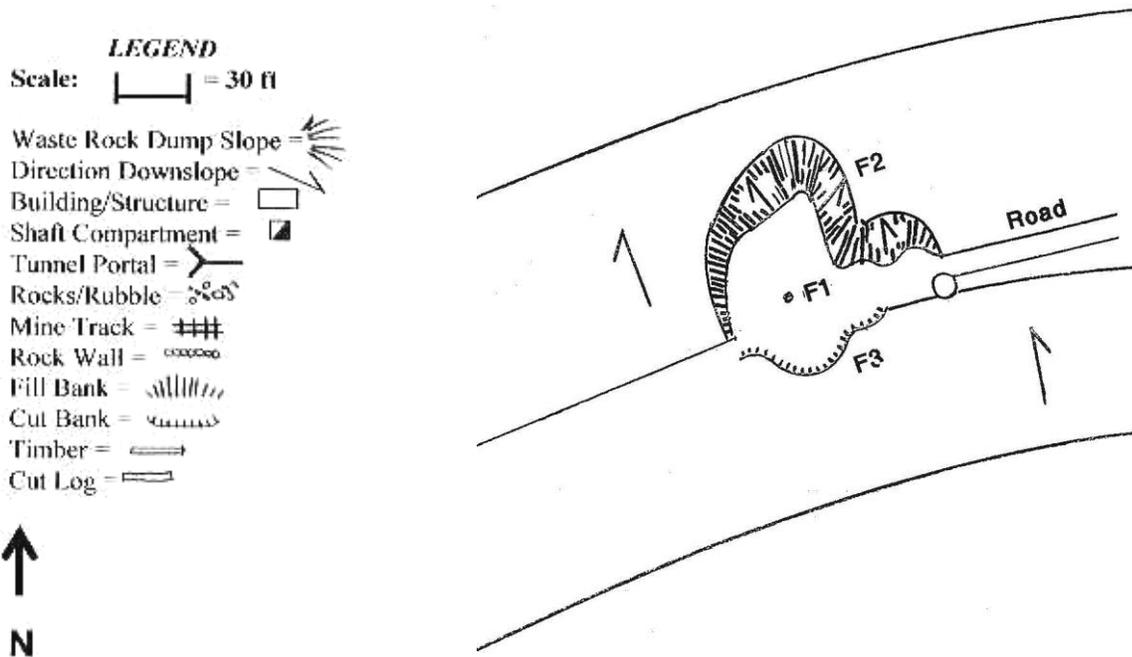
Figure 3.22 Site map for 5GL.2137.

The site described here was a prospect shaft probably sunk during the 1860s to probe the Barker Vein. Later, the vein was worked through two other shafts short distances west and east (5GL.2136 and 5GL.2138). During the late 1980s, DRMS sealed the shaft by installing a concrete plug and then bulldozing waste rock over it. The site was apparently not recorded as a resource at the time.

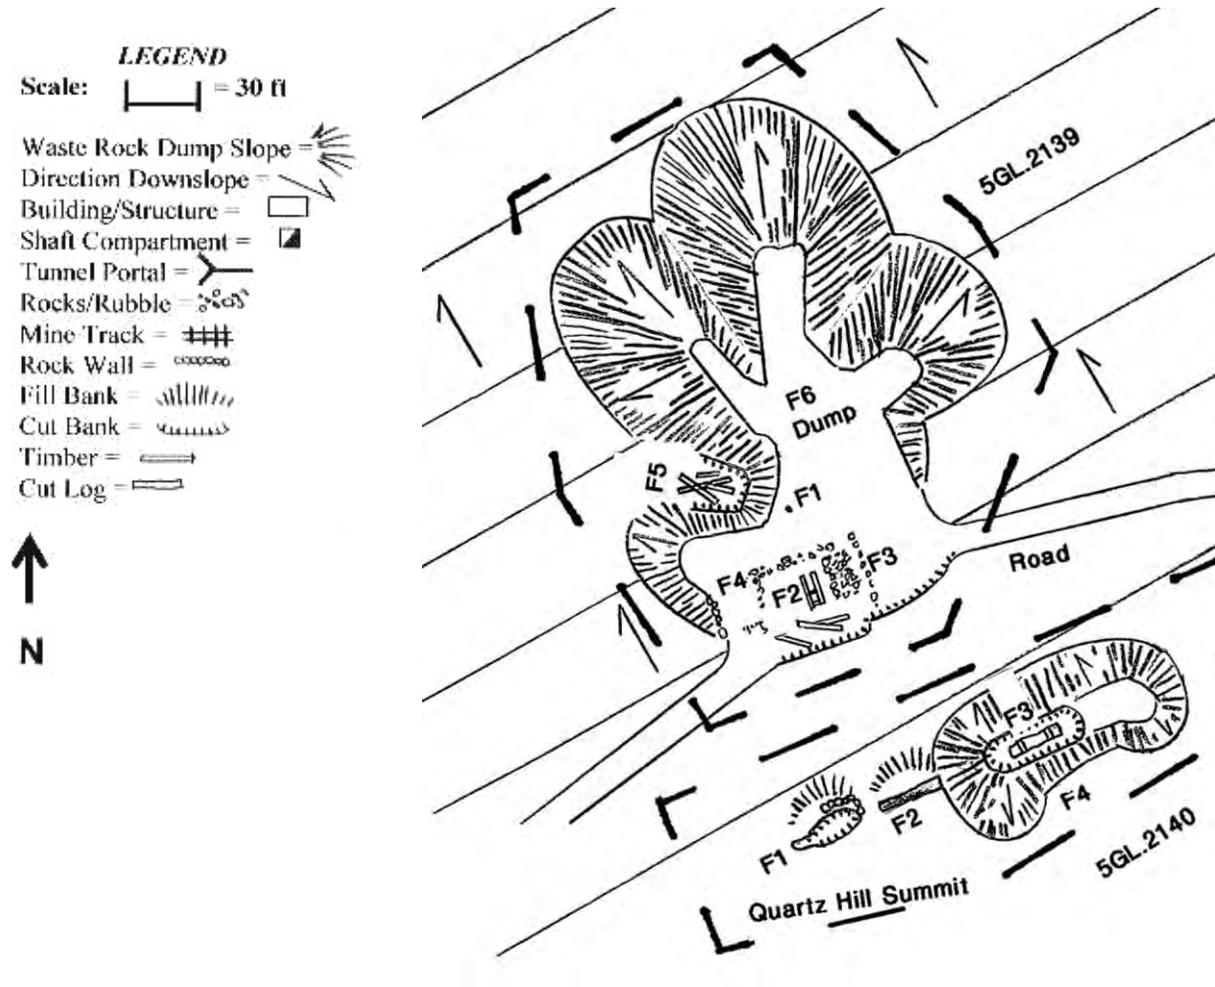
Figure 3.24 Site map of 5GL.2139.

hoist house's center, and a headframe standing over the shaft. A foundation (F2) of 8"x8" timber footers with anchor bolts 6½"x7" in plan represents the hoist. Impressions of timbers for the headframe foundation extend north toward the shaft. The timbers are still in the ground, but have rotted.

The boiler was adjacent to and east of the hoist, and its foundation (F3) remains. The foundation is a dry-laid rock pad 9'x18' in plan, at one time supporting the boiler's rock and brick masonry setting, which is gone.

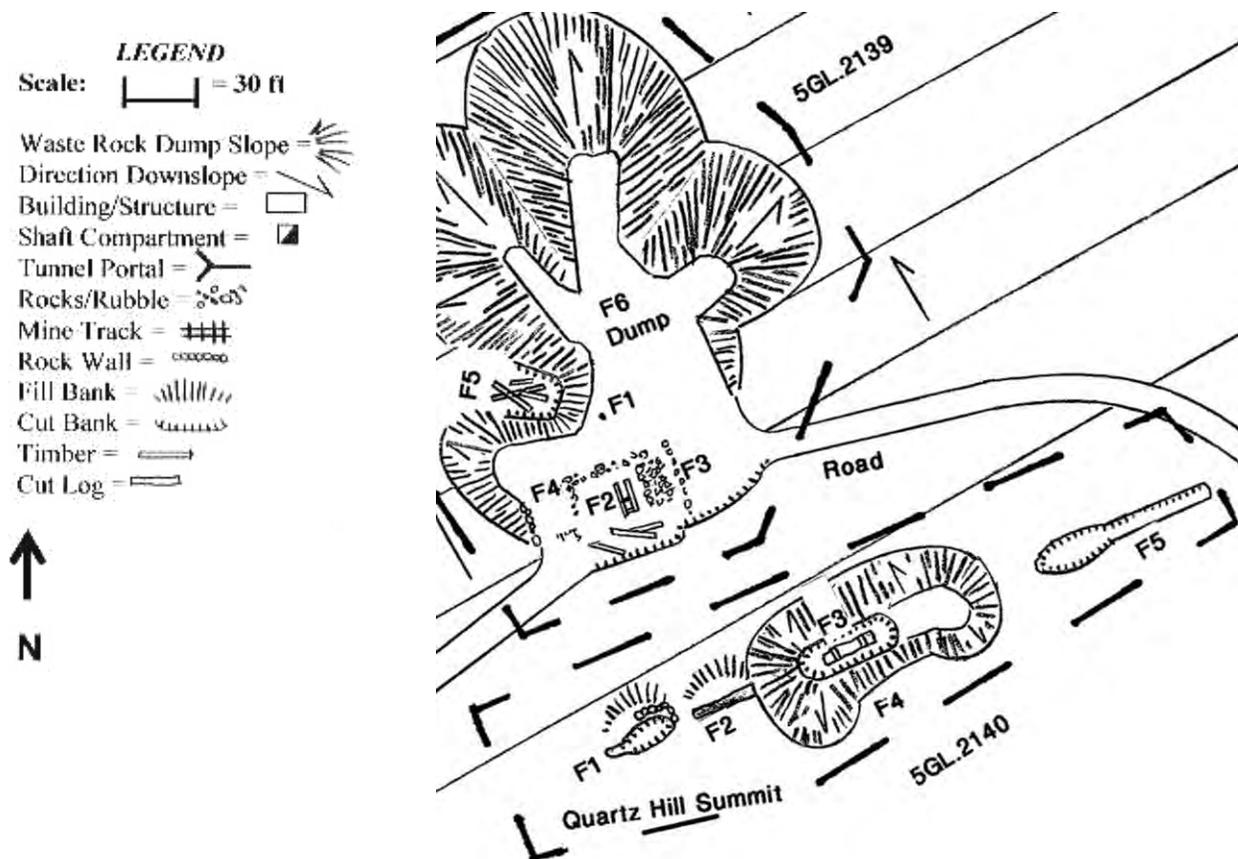
Figure 3.25 Site map of 5GL.2139.

The site is a simple archaeological resource where prospectors found a gold-bearing vein, blasted cuts to sample it, and then stoped a pocket of ore downward. Through their sampling and extraction efforts, the prospectors incised a series of three substantial cuts and a stope totaling 270' long. The site excludes myriad pits and minor trenches dug during the initial search for the vein, crossing east-west along Quartz Hill's crest. In type, the resource is a combination prospect complex and shaft mine.

The site is in marginal condition. The rims of the eastern and western prospect trenches have slumped and partially filled the trench bottoms. The rim of the open stope has also slumped, filling the incision with rubble and waste rock. Thick stands of young aspens have overtaken most of the site, concealing the trenches and covering any small-scale features with humus.

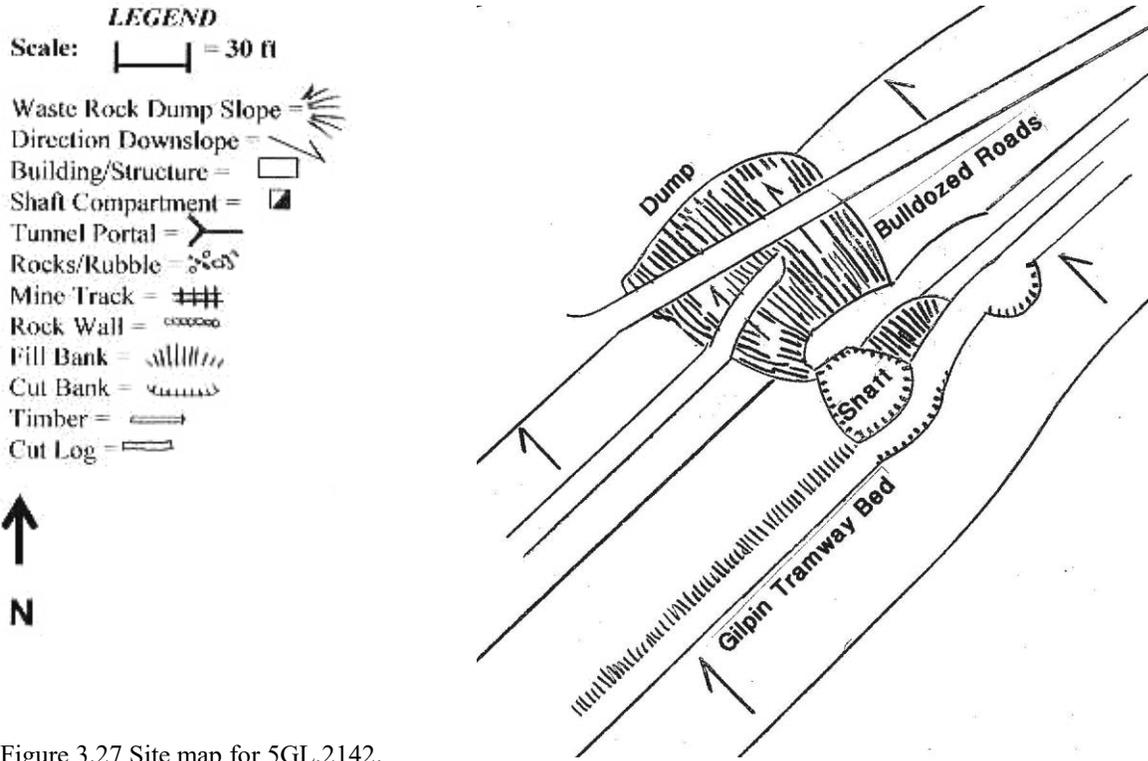
Figure 3.27 Site map for 5GL.2142.

The site discussed here was a secondary shaft associated with the Pease-Kansas, and worked as an independent operation during the 1870s and possibly later. The main shaft (5GL.2143) is around 170' to the west. Today, the site is a poorly preserved archaeological example of a shaft mine. Historically, the operation was simple with few buildings or structures and little equipment. Everything was removed long ago and the shaft collapsed, creating a massive subsidence chamber 36'x45' in area and 15' deep with ragged rock walls. The collapse zone drew in the surrounding shaft house platform and main portion of the waste rock dump, destroying character-defining small-scale features. The dump is now a hummocky fan 80'x92' in area and 5' thick, its flanks cut by three bulldozed roads. A grade for a Gilpin Tramway railroad spur passes around the shaft's south side. The spur at one time extended to the main shaft.

The site possesses few artifacts, limited to a pieces of lumber, cut nails, and disintegrated iron. Cut nails are the only dateable artifacts, reflecting an age range spanning the 1860s and 1880s. Buried archaeological deposits are unlikely because activity tended not to generate material in volume, which was thrown out onto the ground. Further, the deposition environment is not conducive to the accumulation of buried deposits.

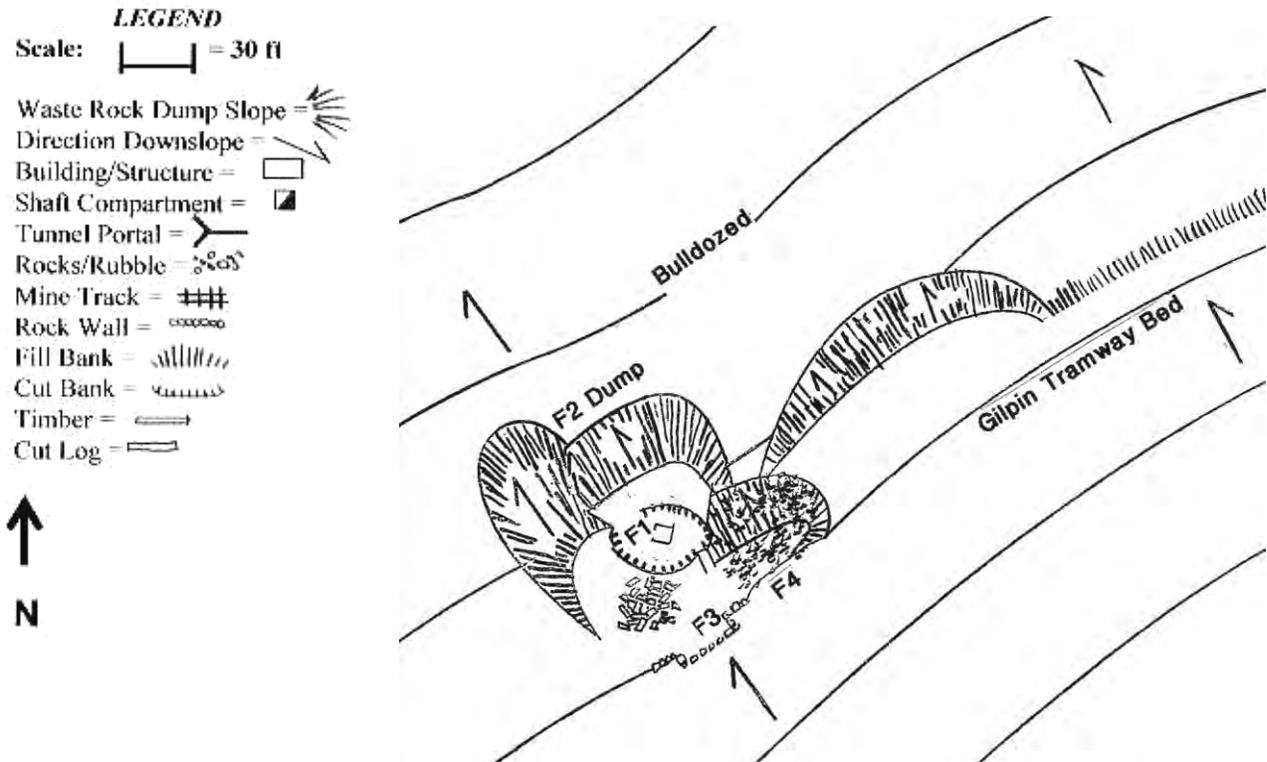
Figure 3.28 Site map for 5GL.2143.

The shaft house platform (F3) is a cut-and-fill bench 32'x36' in area. A partially collapsed dry-laid rock wall 5' high and 45' long retains the cut-bank, defining the southeast side. A minor fill-bank marks the northwest edge, although much was drawn into the shaft when its collar slumped. The platform's surface was scraped once with a bulldozer and is now thickly overgrown with aspen and lodgepole saplings. A mound of earth and decayed bricks on the southwest end may have been a boiler setting. A substantial lobe of boiler clinker (F4), 25'x36' in area, extends east. Boiler clinker is observed as an ashy residue from burning fuel coal, and the lobe's high volume indicates sustained operations.

The site possesses a good artifact assemblage of structural debris and industrial refuse concentrated on the shaft house platform. Structural debris includes lumber fragments, common bricks from a boiler setting, cut and wire nails, and window glass. Industrial materials are shop refuse, pipes, and a few machine parts. In combination, cut and wire nails, and aqua window glass reflect an age range spanning the 1880s to circa 1910.

The site lacks buried archaeological deposits capable of revealing important information. The boiler clinker dump (F4) qualifies as a buried deposit, consisting of ash, clinker nodules, and disbursed artifacts. The dump is not significant because its artifacts are almost certainly general industrial refuse such as hardware and pipe segments, repetitive with existing surface materials. Privy pits could not be identified.

The resource is poorly preserved because shaft collapse, natural deterioration, and aggressive mine closure erased some features and damaged those that remain. The shaft completely collapsed and became a large subsidence funnel that drew in the shaft house platform's northeast portion and waste rock dump's central area. Use of heavy equipment to bulldoze more waste rock into the shaft expanded the disturbance, destroying the dump's historic shape and footprint, as well as small-scale features on the shaft house platform. Thick vegetation then overtook the platform. The surface facilities are no longer clearly represented.

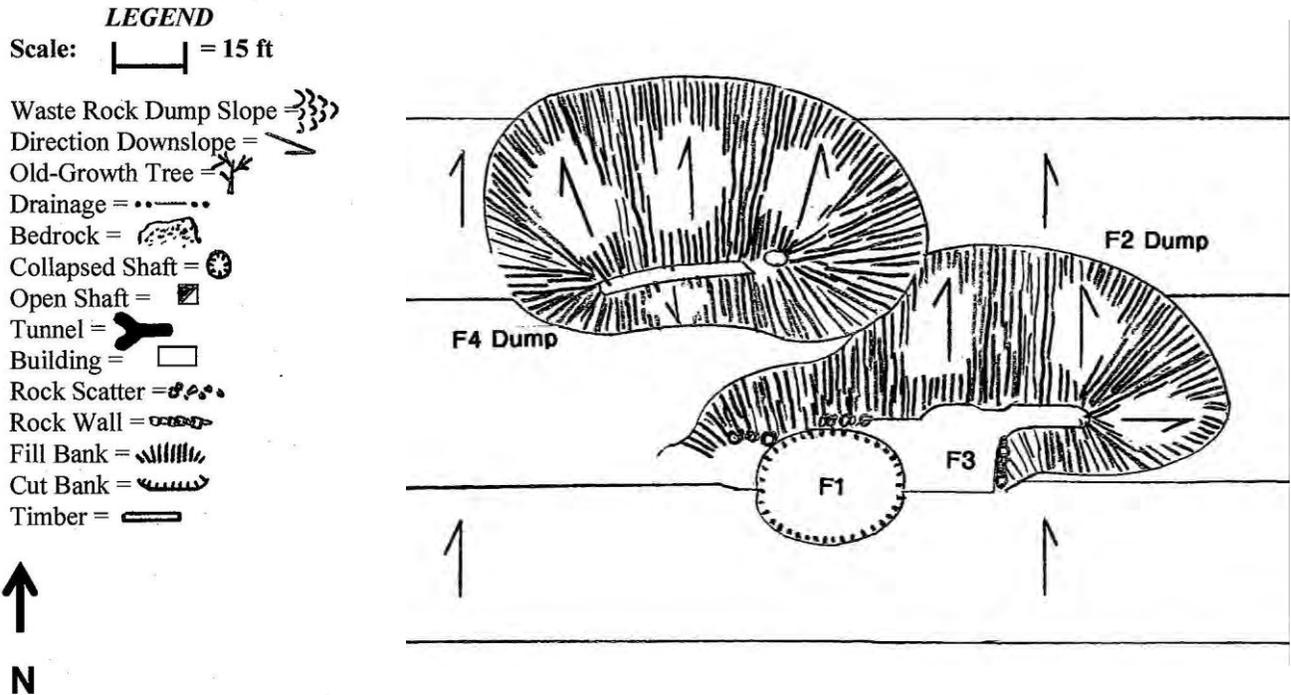
Figure 3.29 Site map for 5GL.2144.

Regarding the site's artifact assemblage, only a handful of cut nails are scattered on the dump. They predate 1890. The site's simplicity and absence of a hoist foundation or shaft house footprint suggests a timeframe of the 1860s or 1870s.

Buried archaeological deposits are unlikely because activity tended not to generate material in volume, which was thrown out onto the ground. Further, the deposition environment is not conducive to the accumulation of buried deposits.

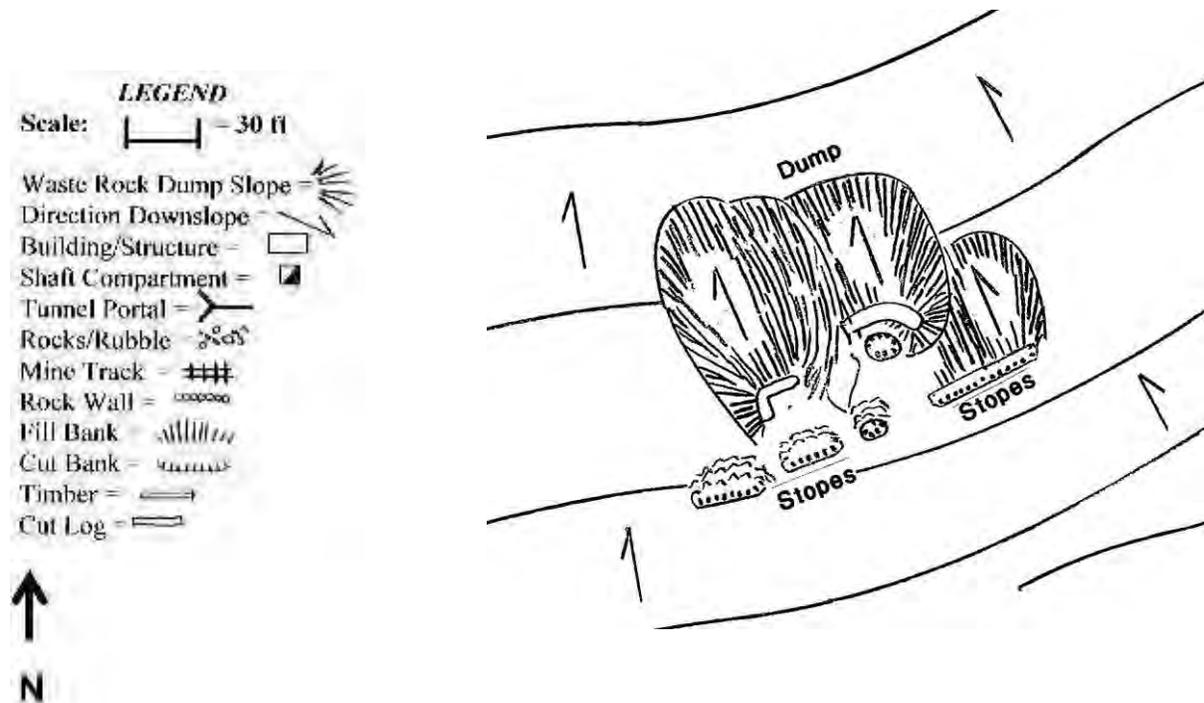
Figure 3.30 Site map for 5GL. 2145.

The rims of all stopes slumped in, creating a 150' series of elongated depressions now overgrown with young pines and choked with rubble. Three fans of pale waste rock extend downslope, blending into one another. The total assemblage is 135' across, 155' long at the west and 57' long at the east, and 9' thick without planned structure or leveled surfaces.

The site possesses an artifact assemblage limited to a few cut nails, reflecting a timeframe predating 1890. Buried archaeological deposits are unlikely because activity was limited to underground work and tended not to generate material in volume, which was thrown out onto the ground. Further, the deposition environment is not conducive to the accumulation of buried deposits.

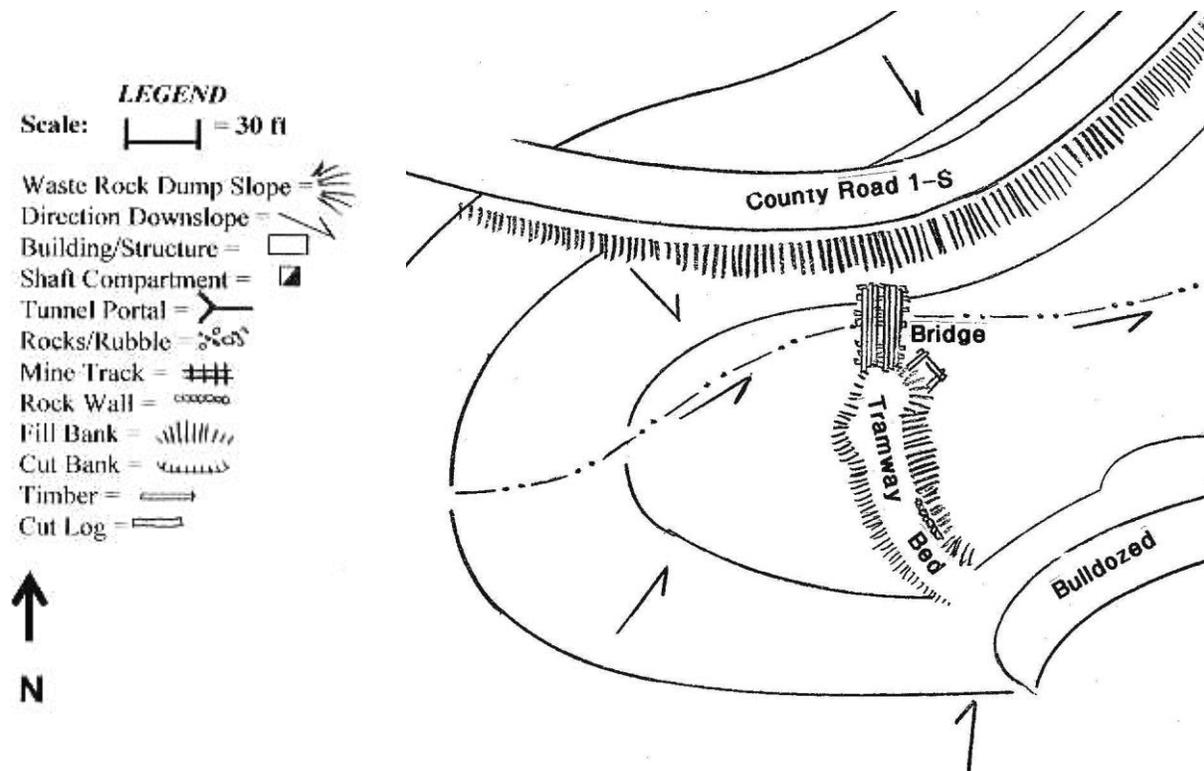
Figure 3.31 Site map for 5GL.2146.

The bed is distinct and characteristic of railroad lines. Graded with waste rock fill, the bed is a berm 100' long, 25' wide, and 3' to 6' thick, its footprint reflecting the gulch crossing's

horseshoe curve. The bed's crown is 8' to 12' wide and surfaced with sand and fine waste rock as ballast for the track, dismantled long ago. At one time, the bed gradually swept southeast and passed through the La Crosse complex, but has since been erased by bulldozing. The bed's north end terminates at the bridge spanning Nevada Gulch's stream channel.

The bridge had carried the spur track from the gulch's south to north side, the track then continuing northeast along Nevada Hill. But widening of County Road 1-S destroyed the northern railroad grade, such that the bridge presently dead-ends against the road's loose fill-bank. The bridge is 35' long, 15' wide, and features original abutments and support piers, while decking was replaced in later decades as an adaptation for small trucks. The abutments consist of log cribbing walls 12' across and 6' high retaining waste rock and local cobble riprap fill. The piers reinforce the cribbing, and are cap-and-post structures 12' across and 9' high. Workers assembled them from hand-hewn 12"x12" timbers fitted with mortise-and-tenon joints. After the spur was abandoned, the bridge was adapted for trucks with a layer of 2" thick plank decking nailed to log joists over 12"x12" timber stringers bolted to the piers. Diagonal braces underneath lend support.

In condition, the bridge is severely dilapidated and threatened with collapse. Storm events have washed out the northern support pier and undermined the southern. The north end has dropped onto the stream-bank and the southeast corner sags, causing the decking to warp. Maintenance of County Road 1-S above deposited rubble onto the north end, exacerbating rot. Despite this, the bridge's survival is noteworthy and a testament to the quality of engineering and construction.

- Preserve the bridge against land use and environmental cleanup, and officially recognize its significance.
- Intensive site documentation and archival research, including objective significance evaluation.
- Stabilize the bridge. Restore the northern abutment, improve the southern abutment, and prevent maintenance of County Road 1-S above from dumping gravel and rubble.

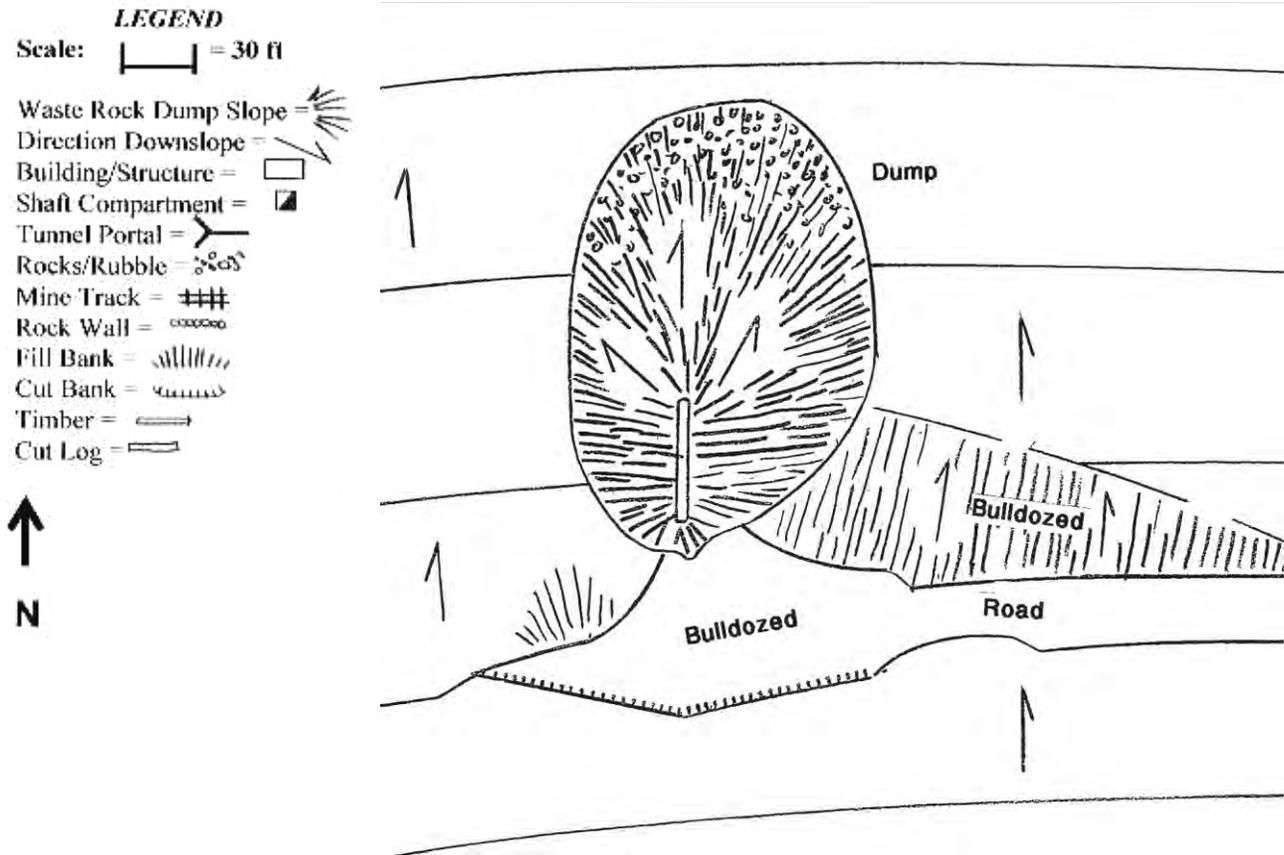
Figure 3.32 Site map of 5GL.2147.

Unfortunately, nearly all evidence of the mine’s surface facilities were bulldozed away during the 1960s or 1970s, leaving a massive waste rock dump. The area where the shaft house, hoist, other buildings, and machinery at one time stood has been repeatedly scraped, destroying even lasting features such as masonry foundations. Presently remaining is a flattened swath approximately 60’x180’ in area with some rockwork.

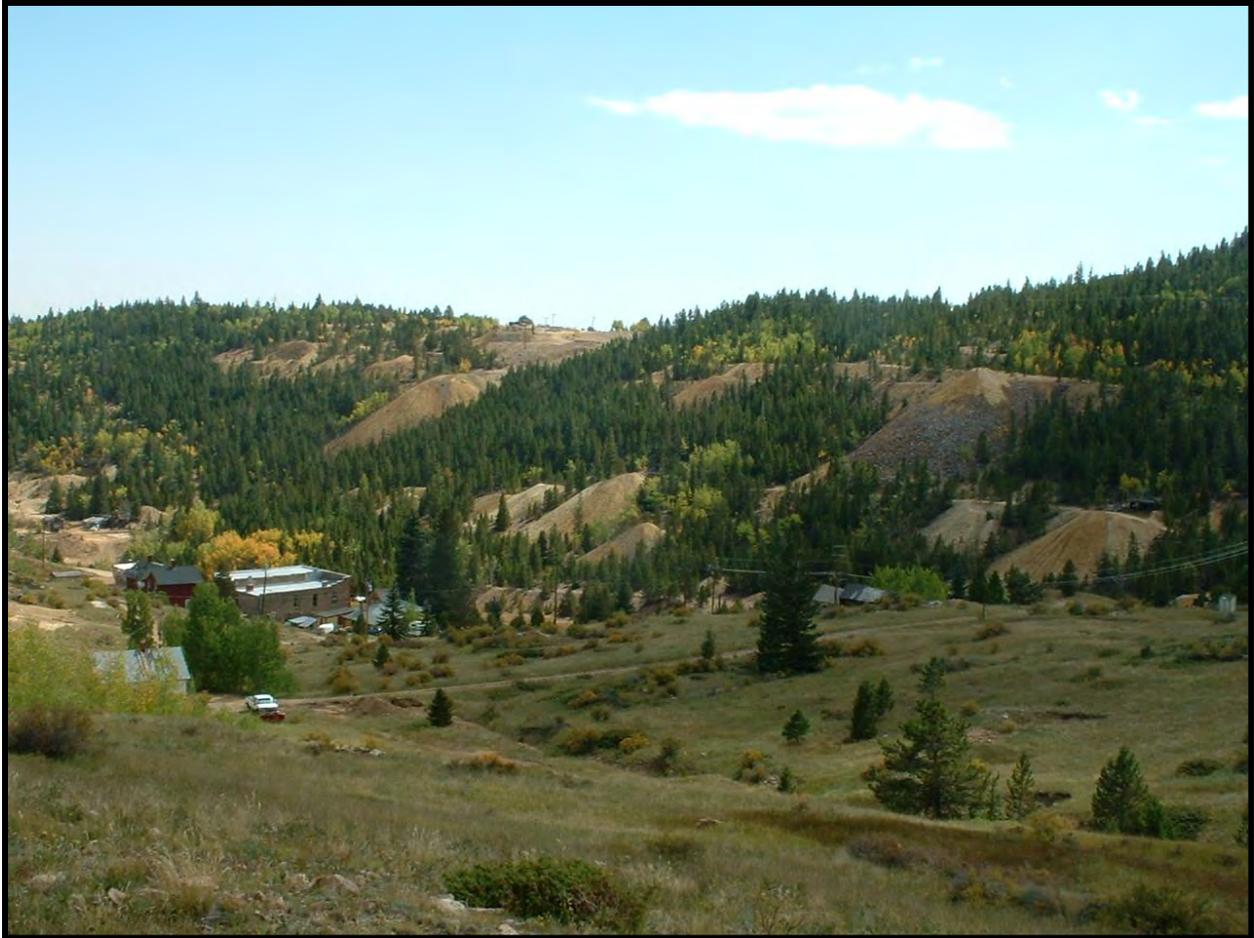
Figure 3.33: Southeast overview of Nevada Gulch. Nevadaville is in left-foreground, while Quartz Hill and its numerous mines are in the background. Quartz Hill forms the gulch's south wall.

The landscape's manmade elements vary. One element is a ground-surface characteristic of intensive mining. Much of the south wall was overturned by placer mining, hardrock prospecting, and hardrock mine development, allowing soil to wash away over time. In its place is a veneer of sand, gravel, and scattered waste rock becoming overgrown with young forest. A circulation system typical of mining is another manmade element. The system includes a network of wagon roads and Gilpin Tramway railroad spurs connecting the principal mines. The roads are narrow, steep, and wind throughout the gulch, while the railroad spurs are broad and contour across the gulch's south wall. Although the roads and spurs are resources in themselves, the overall network contributes feeling and association to the landscape. A third manmade element is a background scatter of structural and industrial debris throughout the gulch, supporting a feeling of past industry.
