Nevadaville Historic Resources Survey: Phase I
SURVEY REPORT
June 2015

Nevadaville Historic Resources Survey: Phase I 2014-2015

Survey Report June 2015

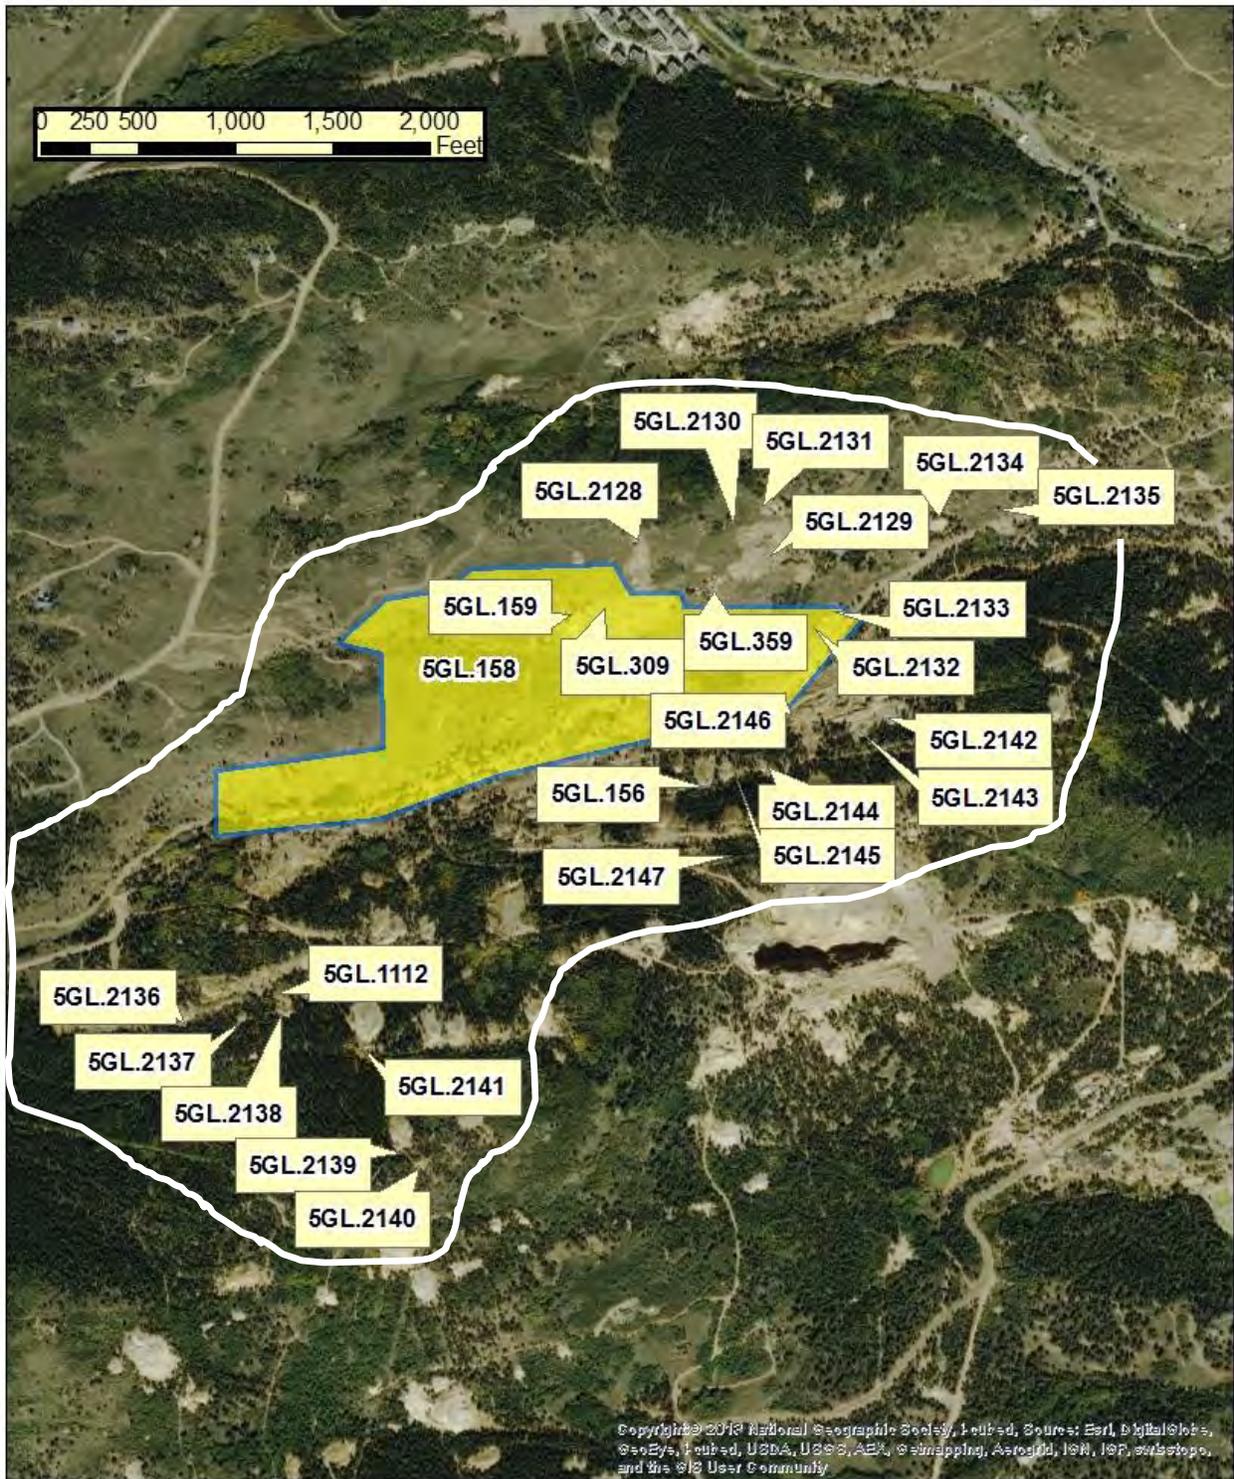
Figure 3.34: The aerial photo illustrates Nevada Gulch’s landscape potential. Nevada Gulch (5GL.158) is the yellow polygon, while the text boxes mark inventoried resources. All the other light blobs are prominent mines. Collectively, they form the gulch’s landscape. The landscape could be designated a new National Register district, approximated by the white line. More survey is necessary to refine the boundary and specify exact content.

Within the setting are hundreds of prospects and mines in varying states of preservation. Bold, visually prominent waste rock dumps mark the more substantial sites, which are visibly connected by the gulch's circulation system. The larger dumps and the railroad spurs are clearly apparent from a variety of vantage points and anchor the landscape. Meanwhile, smaller clusters of pits, trenches, and shallow shafts convey the intensive prospecting that preceded mine development. The prospect complexes on the gulch's north wall are clearly visible, while the complexes on the south wall are located in forested areas and contribute small-scale detail apparent when traversing the landscape.
