Table 3. Historic Resources Survey Phase 1, Nevadaville, Colorado

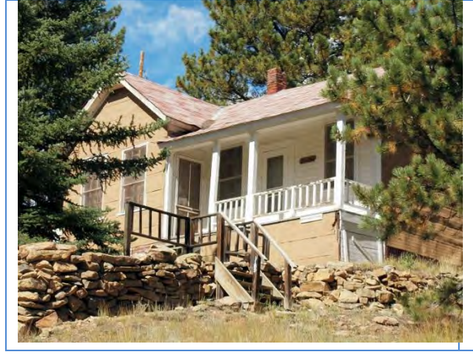
Photograph	Site ID # NHL ID #	Address	Historic Name Est. construction date	NHL District contrib	NR eligible	Local eligible	Integrity Existing Conditions Comments	Historic photograph
	5GL.7.332 N-1	400 Nevadaville Rd.	Nevadaville Building #1	Yes/Yes	Yes B, C	Yes	Date of side additions are unknown, but the large, central stone portion retains a high degree of integrity	
	5GL.7.335 N-14	1069 Nevadaville Rd.	Gest House Nevadaville Building #14	Yes/Yes	Yes A, B	Yes Listed	New siding is similar to the historic siding, and does not negatively impact this building's integrity.	
	5GL.7.336 N-27	1071 Nevadaville Rd.	Rice-Andrews-Paul House Nevadaville Building #27	Yes/Yes	Yes A, C	Yes	Alterations include a shed roof dormer, new doors and windows, and a small frame addition on the side. These do not detract from the building's overall integrity.
